HURSTVILLE LIME KILN STRUCTURAL IMPROVEMENTS

Carson Schuler, Samantha Olson, and Caden Fedeler

Department of Civil and Environmental Engineering
The University of Iowa

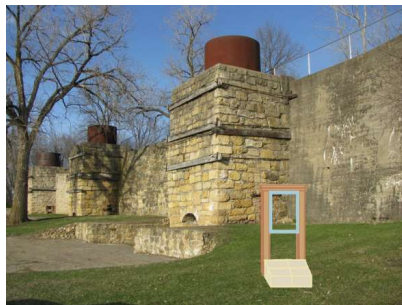
Figure 4 – Viewing Platform

Installation of viewing platforms along the trail route will provide a walking history for patrons of the site with etched glass showing how the site looked when active. The drawings are taken from historic photos of the site. The base of the platform will be constructed from limestone in the area and convey a “stand where they used to stand” idea.

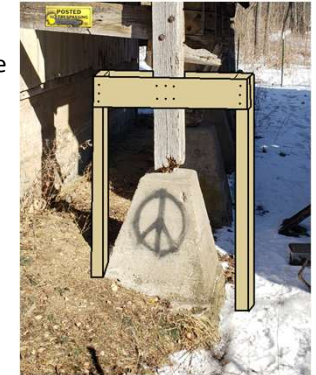
Figure 8 – Temporary Lumber Supports for Rock Crusher Columns

Rock Crusher Building Stabilization: The old building that once held the rock crusher is in poor condition. In an effort to keep the building standing, both temporary and permanent supports will be installed. These supports will help reinforce and repair the most critical members of the structure.
