# The Chadek Property Community Garden

By: The Soil Genesis and Geomorphology Class  
Earth and Environmental Sciences Department  
University of Iowa 2014

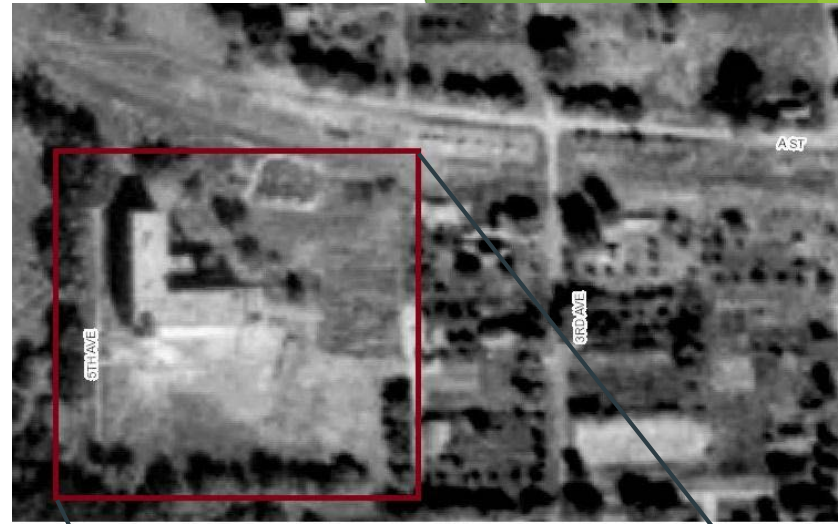
1930

- ❑ 1952: Site purchased by Mr. Carl Chadek
  - ❑ Utilized as a play area for neighborhood children
  - ❑ Mr. Chadek also stored dirt and gravel associated with his trucking business located in the eastern adjoining property
- ❑ 2008: Site was purchased by the City of Iowa City
  - ❑ Remnant structure remained on northwest corner of the property, and was later removed

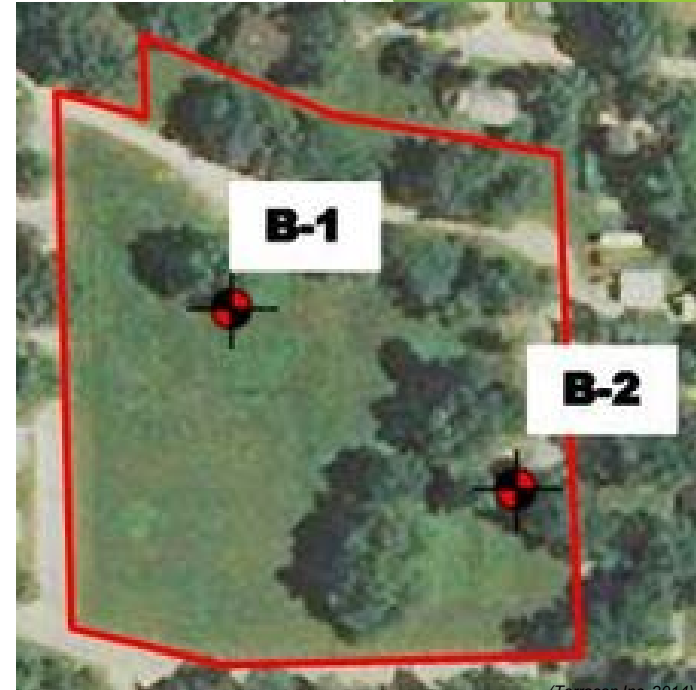
(Terracon Inc. 2014)

# Limited Site Investigation (LSI)

**Table 1: Results of TEH and RCRA Metals Analysis of Soil Samples (mg/kg)**

Parameter	B-1	B-1	B-2	SWS for Soil
	(0-4')	(10-12')	(10-12')	
<b>TEH</b>				
Waste Oil	NA	<9.90	29.2	NA
<b>RCRA Metals</b>				
Barium	184	91.1	NA	15,000
Chromium	20.7	18.2	NA	97,000
Mercury	0.0229	<0.0235	NA	23

**Table 2: Results of SVOC and RCRA Metals Analysis of Groundwater Samples (mg/L)**

Parameter	B-1GW	B-2GW	SWS for a Protected Groundwater Source
<b>SVOCs</b>			
Bis(2-ethylhexyl)phthalate	0.000394	0.000557	0.006
<b>RCRA Metals</b>			
Barium	0.139	NA	2
Selenium	0.00721	NA	0.05

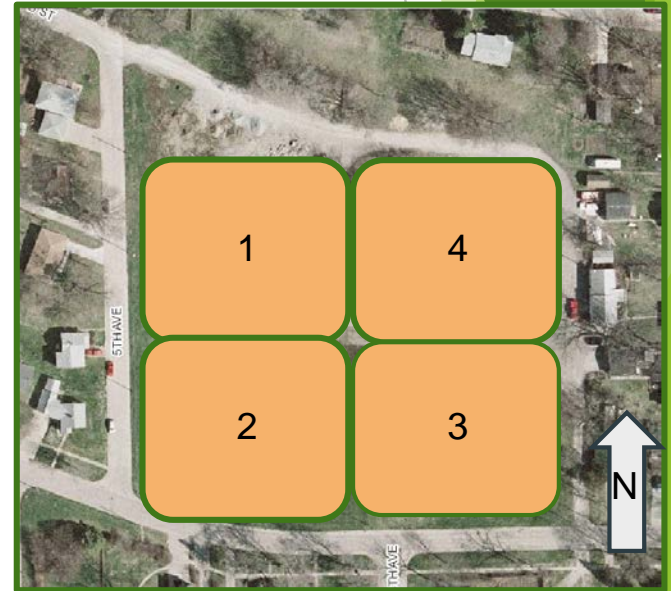
Quadrants 1-4

# Soil Unit Descriptions

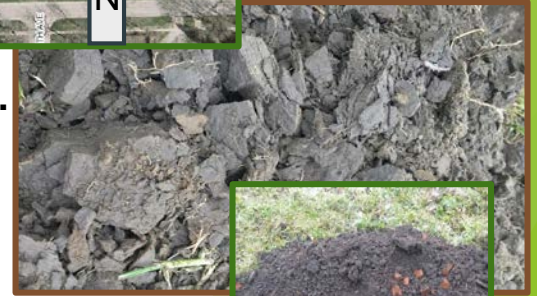
# Quadrant 1

- ❑ Soil was heavily compacted
- ❑ Large amounts of fill were present throughout, adding to the soil's compaction, and making it difficult to obtain soil profiles in this area.
- ❑ Cement or brick fill was found between 5-15 cm in each sample.
- ❑ Much of the area contained the cement/limestone pad lying just inches under the surface remaining from the original building, as well as bricks and other artifacts from the production of materials on the site.

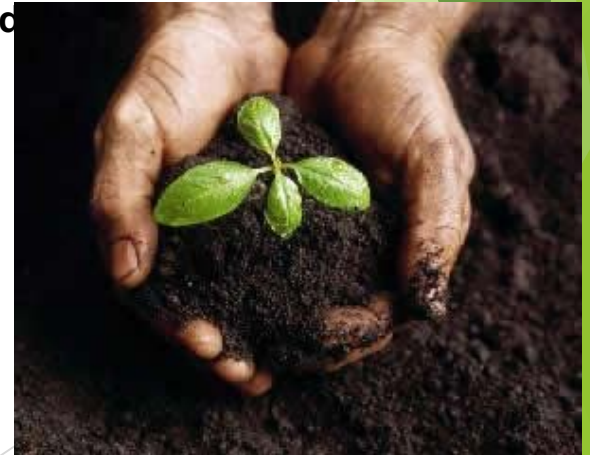
# Quadrant 2

- Horizons were clearly defined and included thick topsoil horizons
- Clayey subsoil horizon beneath the topsoil layer
- A topsoil horizon much thicker in SE portion of Quadrant 2
- In the SE corner of Quadrant 2 a thin layer of rubble was found
- Soil is more compacted along the roadside to the west

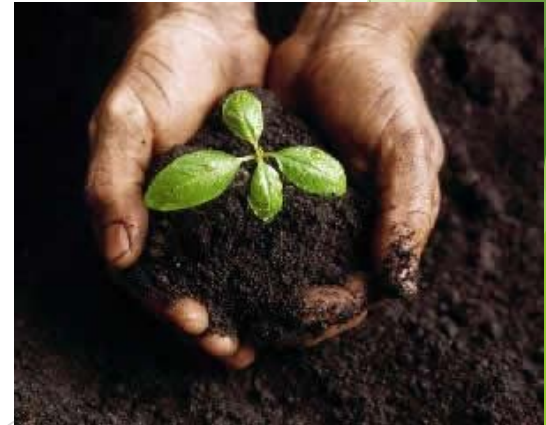
# Quadrant 3

- ❑ Well-defined soil horizons
- ❑ Thick topsoil with clayey subsoil
- ❑ Little amounts of rubble found in first 10cm of soil in very E portion
- ❑ Soil more compacted along S portion

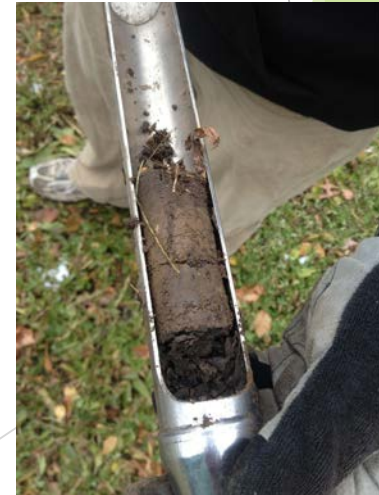
# Quadrant 4

- ❑ Soil compaction is high in the W portion, average compaction in N-central portion. Low compaction in E portion due to gravel in subsurface.
- ❑ Soil in SW portion is mixed, back-filled soil, with ceramic glass and bricks in subsurface.
- ❑ Soil in the SE portion has gravel scattered on surface and subsurface.
