Agency Street Trail

City of West Burlington, IA
Emma Oelmann & Blake Misfeldt, University of Iowa

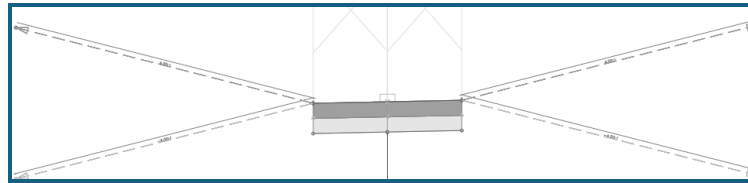
Figure 9: Pavement Cross sections

Using AutoCAD's Civil 3D, the trail is designed 10' wide with 6" thick pavement and 6" subbase with 4:1 daylighting. This team recommends an 8' clear space between the new trail and the roadside. The trail should avoid utility obstructions and provide pedestrian access to businesses. A trail should connect to the mall/Target intersection to provide pedestrians access to a safer crossing.

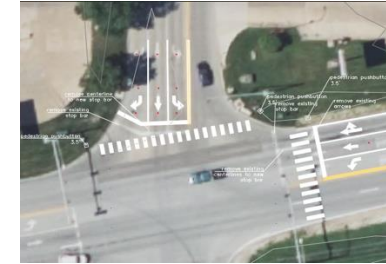
Figure 3: Broadway St & Agency St intersection

- The intersections use longitudinal crosswalks for better visibility.
- Standard curb ramps are implemented on each end of the crosswalks to meet existing pavement.
- Stop lines are implemented to provide a safe distance from stopped vehicles.
- Existing traffic detectors in the pavement need to be moved back with new crosswalk.
- Existing stop lines must be removed.
- Agency St, West Burlington Ave, and Gear Ave lane indicator arrows need removed and repainted farther back.
- Stop signs on Division St & Broadway St intersection need moved by new stop line.
- Detectable warning surfaces on each curb ramp.

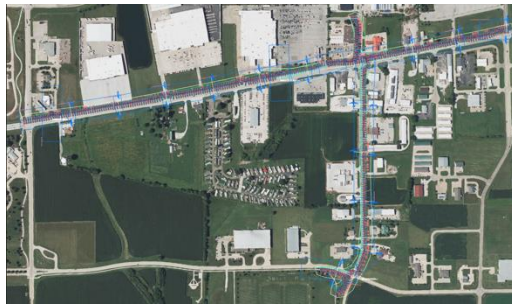
Figure 2: Trail Layout

This trail project starts at the existing Gear Ave trail in West Burlington, IA, and connects the existing sidewalk across West Burlington Ave. A second portion of the trail connects an existing sidewalk north of Broadway St to extend south to meet the existing trail at the RecPlex. With implementation of this new trail, the intersection must be safe for pedestrians and intersection evaluations must be simulated.

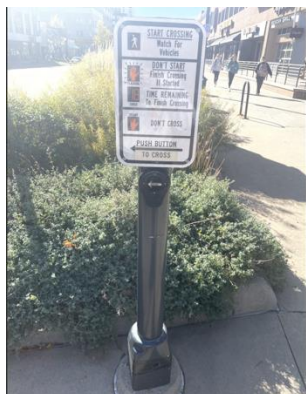
Figure 7: Stand-alone pedestrian pushbuttons

Stand-alone pedestrian pushbuttons are installed at each end of the crosswalk, as in Figure 7.
