# Vinnies Lounge Rehabilitation Project

# CIVIL & ENVIRONMENTAL ENGINEERING

## PROPOSED TO THE CITY OF CLINTON IOWA

PROJECT LOCATION: 224 5<sup>TH</sup> AVE S, CLINTON IOWA

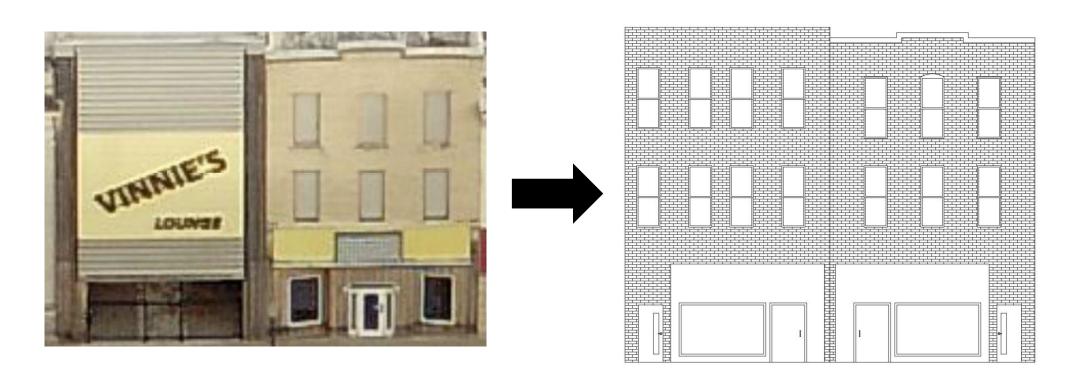
#### REMOVING THE EXISTING FACADE

We are removing the existing façade of the building and restoring the face of the building back to its original brick.

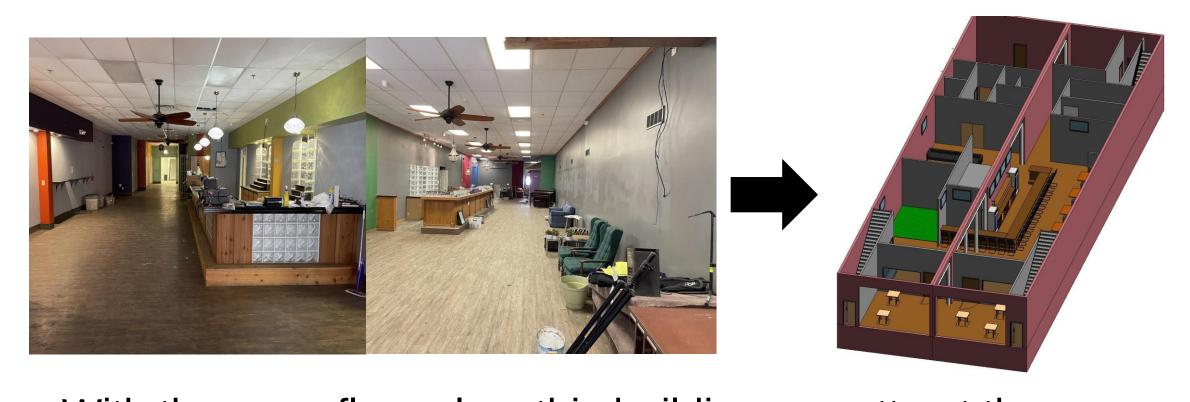
#### CREATING AN UPDATED OPEN FLOOR PLAN

There was a need for this building to feel more open become one building rather than two.

With the open floor plan, this building can attract the younger crowd in town with a more modern, industrial feel to the interior as well as two golf simulator stations for groups of friends to gather and have a good time.

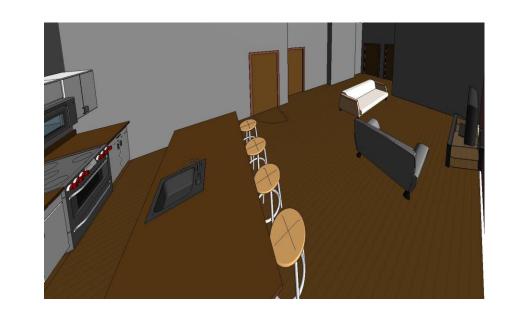
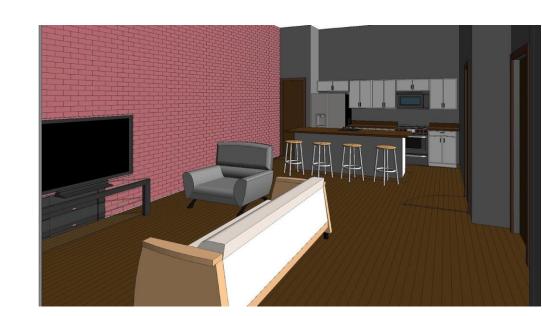
Clinton Iowa wants more of the younger crowd in town. The upper floors of the building are to be renovated into unique updated apartments with many amenities for the tenants to access to.

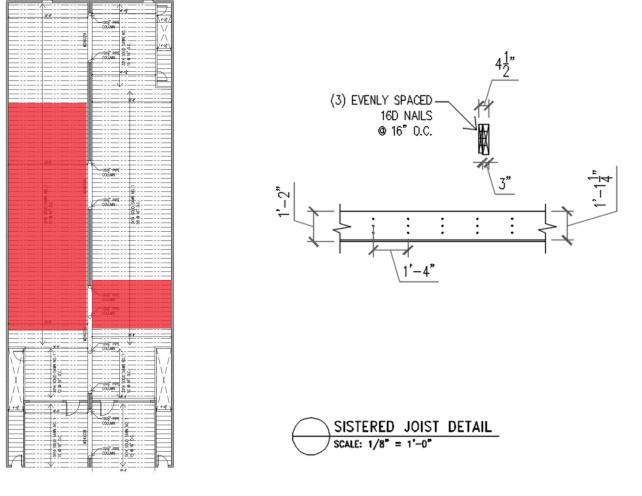
#### JOIST REINFORCEMENT

There are heavier additional loads that applied to certain parts of the upper floors. Because of this joists in this area need to be reinforced with more joists, a process called sistering.

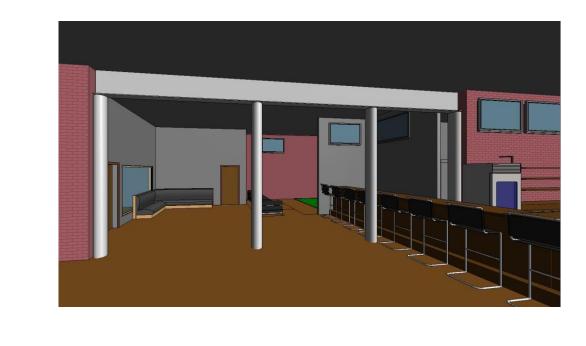
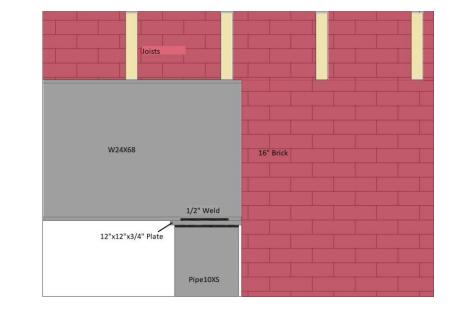
#### Wall Opening Supporting Structure

After removing large sections of the middle wall, the load needs to be supported. There are four openings that need support. A W-flange beam with pipe column structure was designed to support the openings.

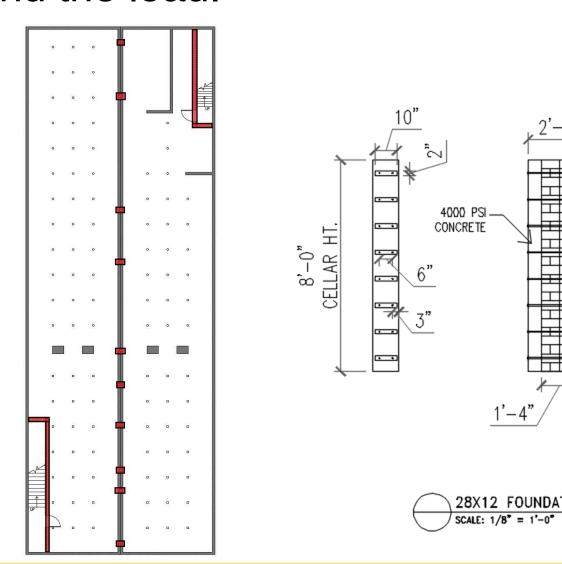
#### **NEW FOUNDATION SUPPORTS**

The loads that the steel columns apply to the foundation brick wall are too large for the wall to support. Foundation concrete reinforcement columns were designed to withstand the load.

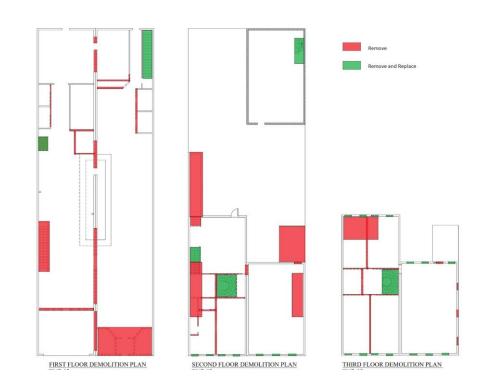
#### DEMOLITION

Most of the existing non-load bearing walls will be removed from the building. All flooring, and ceiling material will be removed and replaced. All windows will be removed and placed as well as the doors. All but one staircase will be removed.

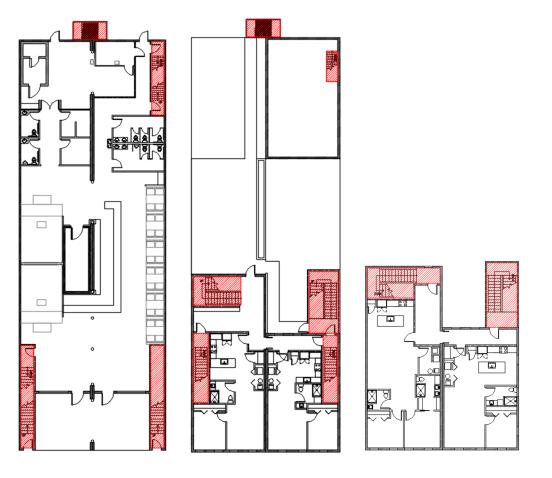
NEW STAIRCASE PLACEMENT

Highlighted in red are the placements of the new staircases in the building.

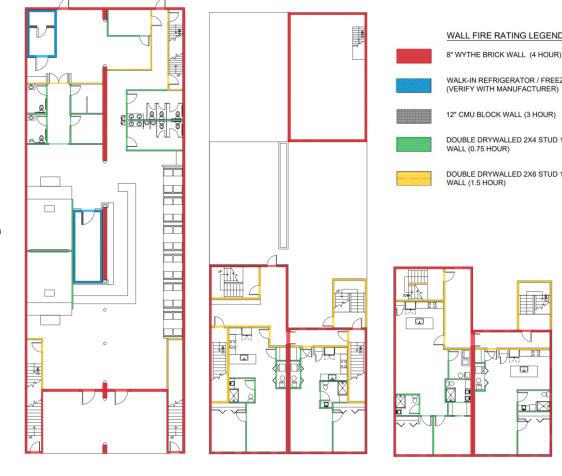
#### FIRE SAFETY

In pictures to the right, the different wall types are highlighted based on the fire rating hours.
