Clinton, Iowa Residential Building Renovation

JBS CONSULTANTS

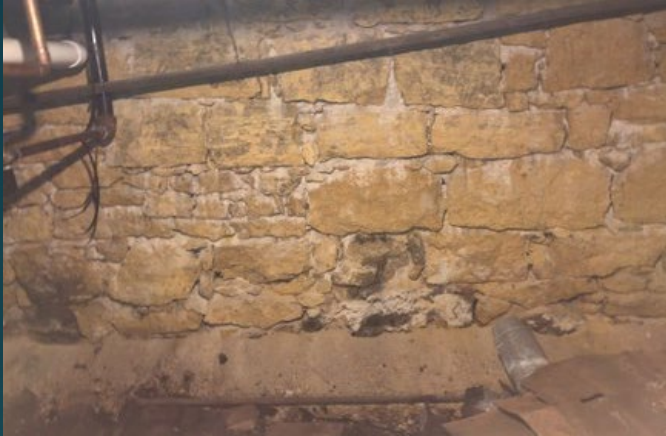
Limestone Foundation

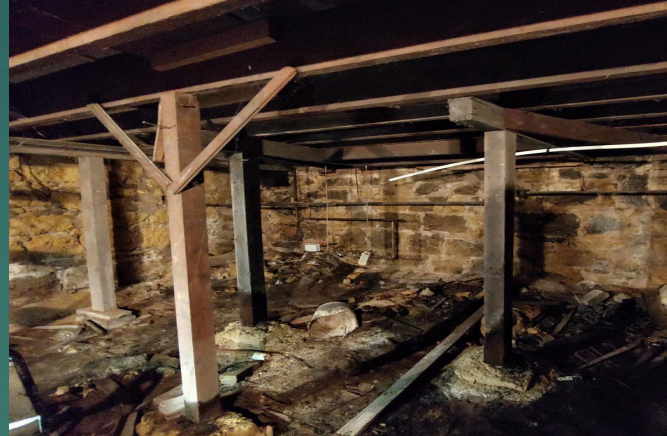
Structural Framing

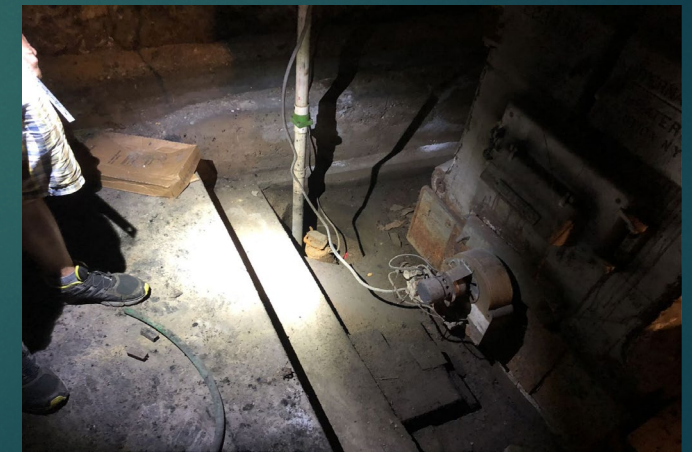
Depressed Boiler Pad

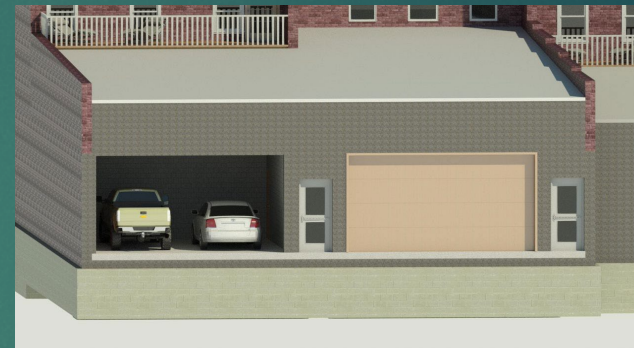
Garage Header Detail

Weyerhaeuser LVL 4x10

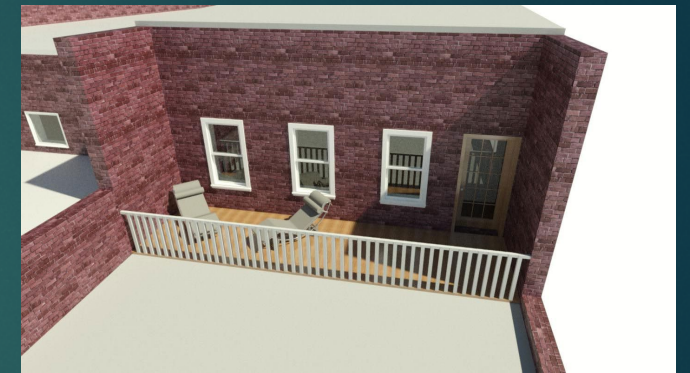
Deck Structural Details

Weyerhaeuser TJI 360 16" joists

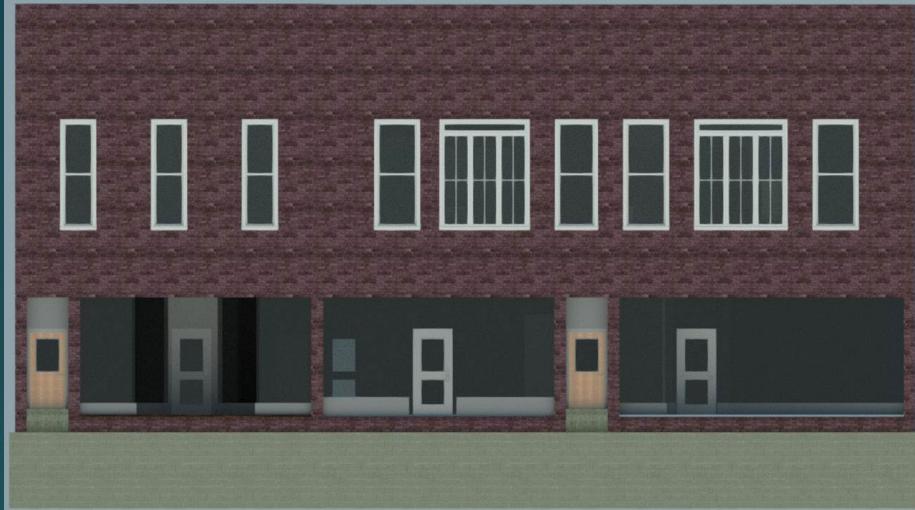
North Elevation Plan

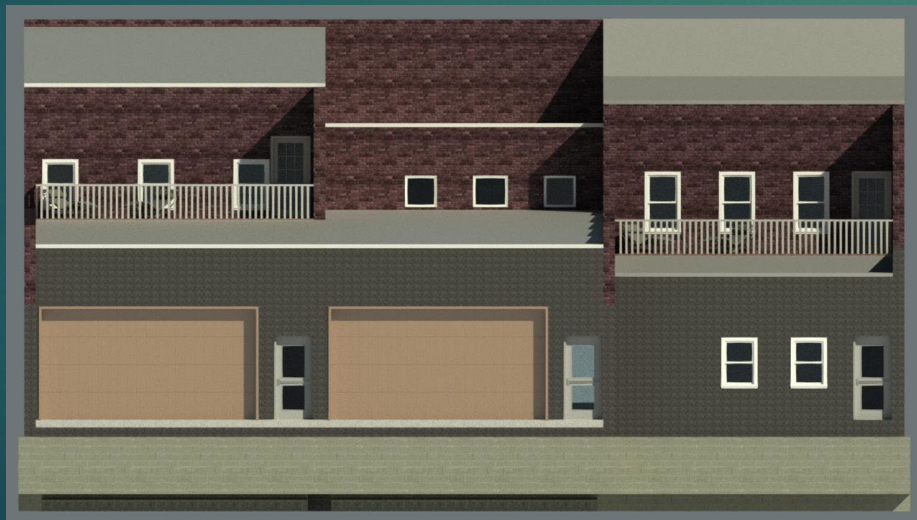
South Elevation Plan

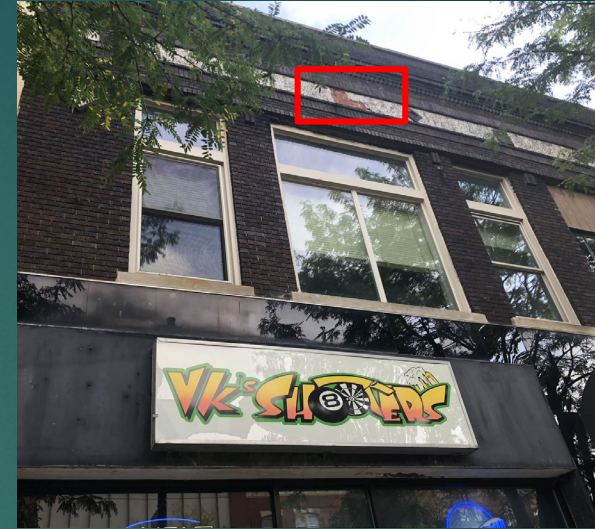
Repointing, Sandblasting & Cleaning

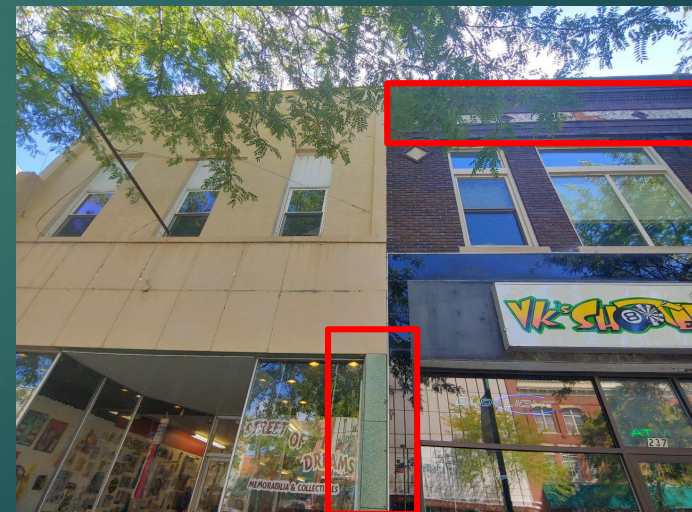
Removal of Stucco Material
