Title	Camp Courageous- Potable Water Master Plar
Completed By	Christian Arnett, Madeleine Murphy, Mya Wallace
Date Completed	December 2021
UI Department	Department of Civil & Environmental Engineering
Course Name	CEE:4850:0001 Project Design & Management
Instructors	Paul Hanley & Richard Fosse
Community Partners	Camp Courageous, Maquoketa River Watershed Management Authority, Iowa DNR, Rebecca Ohrtman Water Quality Consulting L.L.C.

Potable Water Master Plan

Prepared for: Camp Courageous 12007 190th Street Monticello, Iowa 52310

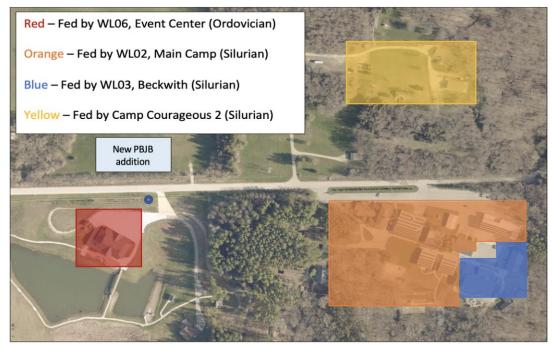
Figure 1.1 Map of well supply to each building; the blue circle represents location of dry hydrant connected to Lake Todd for fire protection

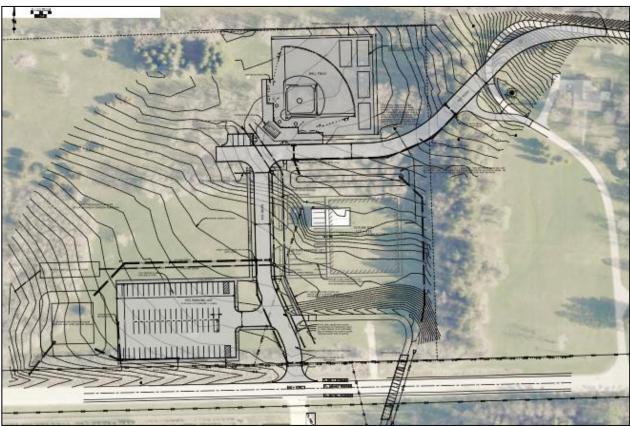
Figure 5.4: Pitlik-Beckwith-Johnson-Bader (PBJB) Addition Site Plan

the potential demands of the camp. Development plans of Camp Courageous are shown below in Figure 5.4

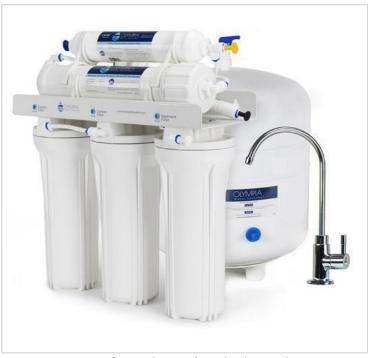
Figure 5.5: Point of Use device (Applied Membranes , 2020)

One of our initial short-term solutions was to install a point-of-use (POU) or point-of-entry (POE) filtration system. POU systems treat water right where you use it and can be installed on all faucets, including shower heads, that supply water to the campers and the staff. In Figure 5.5, a POU reverse-osmosis system is shown as example. With approximately 120 faucets and 90 shower heads to account for, this solution was not considered practical. Ongoing maintenance and replacing filters would provide additional work for the staff at Camp and would not provide any additional benefit when compared to the current treatment system. In addition, it was thought that the effect on water pressure that POU filters would have on specific buildings would be a concern. Water pressure may also be a concern for a POE system; however, this was thought to be a more practical system for the water demand.

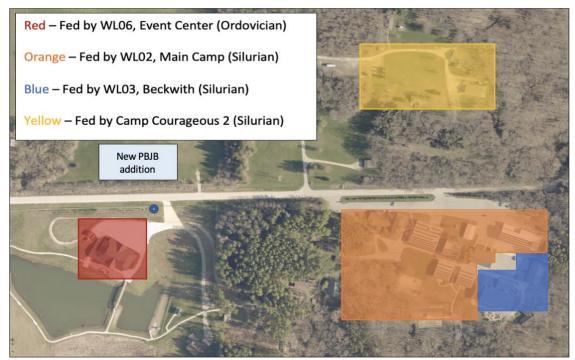
Figure 6.2 Map of well supply to each building; the blue circle represents location of dry hydrant connected to Lake Todd for fire protection

The figure below, Figure 6.2, shows which buildings are fed by each well. Camp Courageous 2 (north well) and WL02 (main lodge) are both treated with softening, anion exchange and chlorination, while WL03 (Beckwith) and WL06 (event center) are only treated with softening and chlorination.
