Title Historic Rehabilitation: Schmidt Building

Course Name CEE:4850:0001 Senior Design

The following document is a complete report prepared by NYT Engineering for the preliminary design of the historic rehabilitation of the Schmidt Building requested by the City of Manning. NYT Engineering is located at 103 South Capitol Street in Iowa City, IA. Our team is comprised of three senior civil engineering students, Nawaf Sultan, Yinjie Ma, and Tanner Wynn, pursuing bachelor's degrees in the University of Iowa's ABET accredited Department of Civil Engineering. Nawaf Sultan is the project manager and was responsible for the structural stabilization of the eastern facade. Yinjie Ma is the technical support and was responsible for the roof repair and architectural design. Tanner Wynn is the editor was responsible for structural design of the floor systems and load calculations

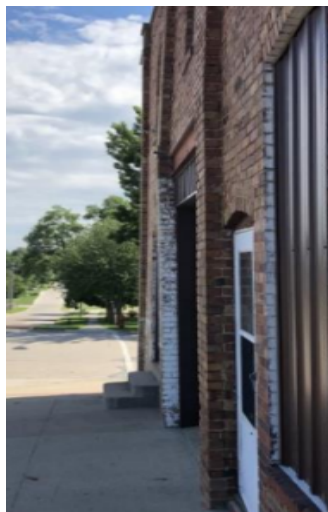
There were four main areas of the building that needed to be repaired to ensure the building remained safe. The first was the building's eastern facade. It was determined that the facade was bowing outwards due to the deterioration of the ties to the clay structural wall. That damage was caused by weathering where the ties rusted away or disconnected from the anchoring points. The age of this building and the thermal expansion and contraction are the two major players that caused the type of damage that this building underwent. There are other causes, such as the material, type of the anchors, and poor water-proofing. Buildings in Iowa generally have freeze-thaw cycles, which speed up the process of deteriorations of materials. Figure 1 illustrates a side section of the building where the veneer wall is displaced from the original vertical location.

Figure 1: View of bowed facade.

The building's front facade is the most immediate item that needs to be addressed. Throughout the years, the brick veneer has bowed outwards due weathering and to frost heave of the sidewalk that supports it.

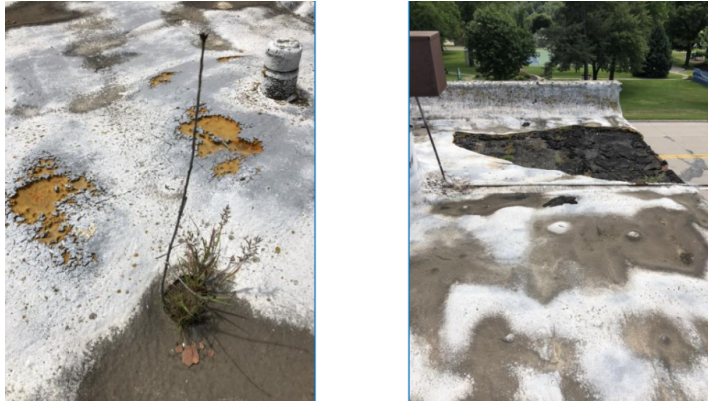
Second is the building's roof. Large portions of the roof are leaking due to weathering and have caused water damage throughout the building (Figure 2).

Figure 2: View of exposed insulation and damage on lower roof.

There is evident problems with the exterior of the lower roof and water damage throughout the building. During our initial inspection, not much of the roof framing was visible, but is expected to have experienced water damage.

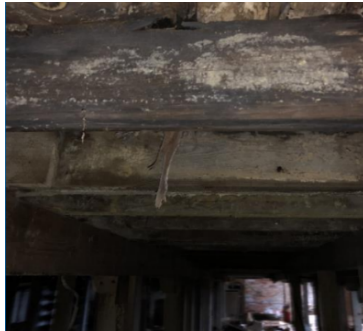
The entirety of the exterior of the roof will need to be replaced and we expect approximately 50% of the roof framing will also need to be replaced. Third is the building's first floor framing. Most of the wooden members have experienced severe water damage and need to be replaced (Figure 3 and 4).

Figure 3: View of main floor framing.

The first floor framing has experienced extensive water damage and a majority of it is rotted. The bottom of the floor framing posts have also degraded due to water exposure.

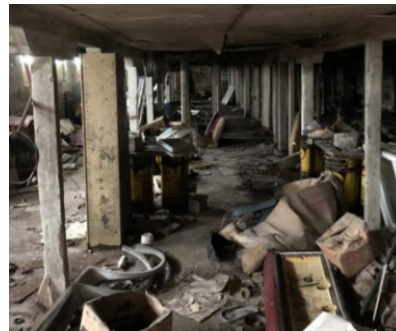
Figure 4: View of floor framing posts.

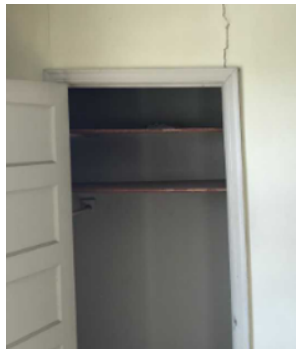
The fourth area of concern is the second floor framing. Over the years, the floor has experienced creep, which has made it slope downward in the center significantly and needs to be made level.

Figure 5: View of Sloped Door Frame

The middle section of the second floor framing is sloped downward. We believe this is due to the wooden girders experiencing creep over time.

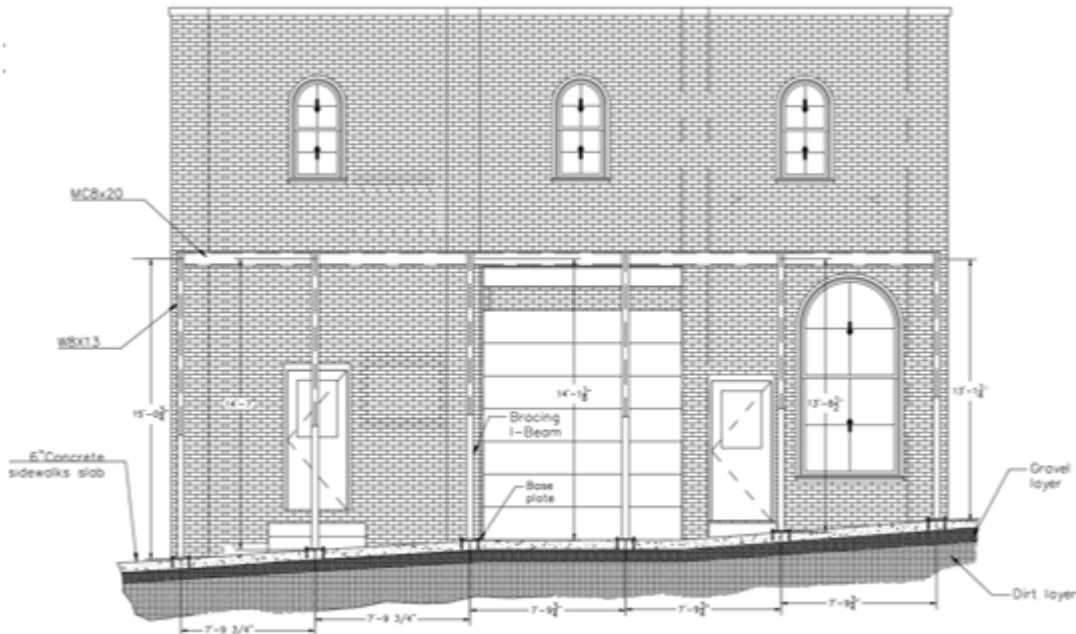
Figure 10: Elevation View of Bracing

After the columns have been installed, five C-Channel beams can be installed on the flange of the I-beams that are facing the building where the web of the C-Channel is flush on the flange. The connection must be made on site by using 2-1/2" long, 3/4" diameter bolts. Two bolts will be needed for each side of the C-Channel. Bolt locations and measurements can be found in the plans and specification sheets.

The C-Channels are MC 8x20 that are about 7'-10" in length. The exact length only can be determined after the columns are installed and plumbed, therefore, the C-Channels must be delivered at 8 feet in length and cut onsite for the exact length. The C-Channel beams will be installed on the columns at the point of maximum outward bowing on the face of the building, approximately 14 feet from the bottom of the garage door. The C-Channels are installed to support manual 1-ton hydraulic jacks that can be mounted at different locations along the C-Channel beams as needed. No more than two jacks can be installed per C-Channel. The jacks will have about 5 feet extension rods. At the end of the rods, there will be a plate for distributing the load on the facade. That plates can vary in sizes depending on the location and as needed. After the facade is pushed to the correct vertical location, the facade will be supported temporarily.

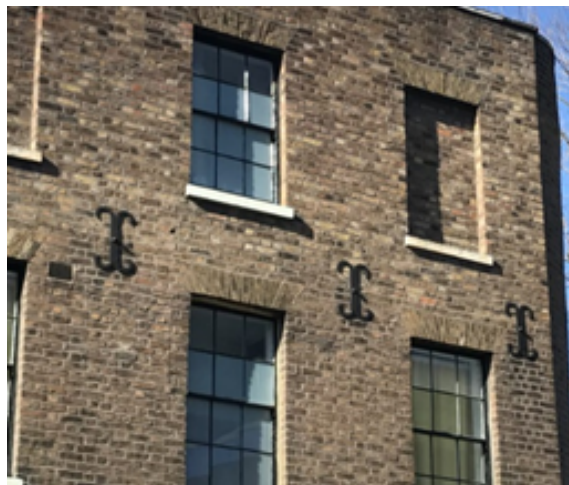
Another option would be to use the same the idea of drilling a pilot hole through the veneer, and instead of using the is CTP Stitch-ties, using threaded stainless bolts that will be anchored to the clay tile. These would have a decorative look and act as a supporting plate for larger area as shown in Figure 13. By having large anchored area, it would reduce the number of Dovetail Triangular Anchors, meaning less materials and installation time. That would lead to cutting cost, but with this type of installation, the spacing would need to be re-designed. There are no plans or specifications provided within this report for this type of anchoring.

Figure 13: Decorative supporting plate

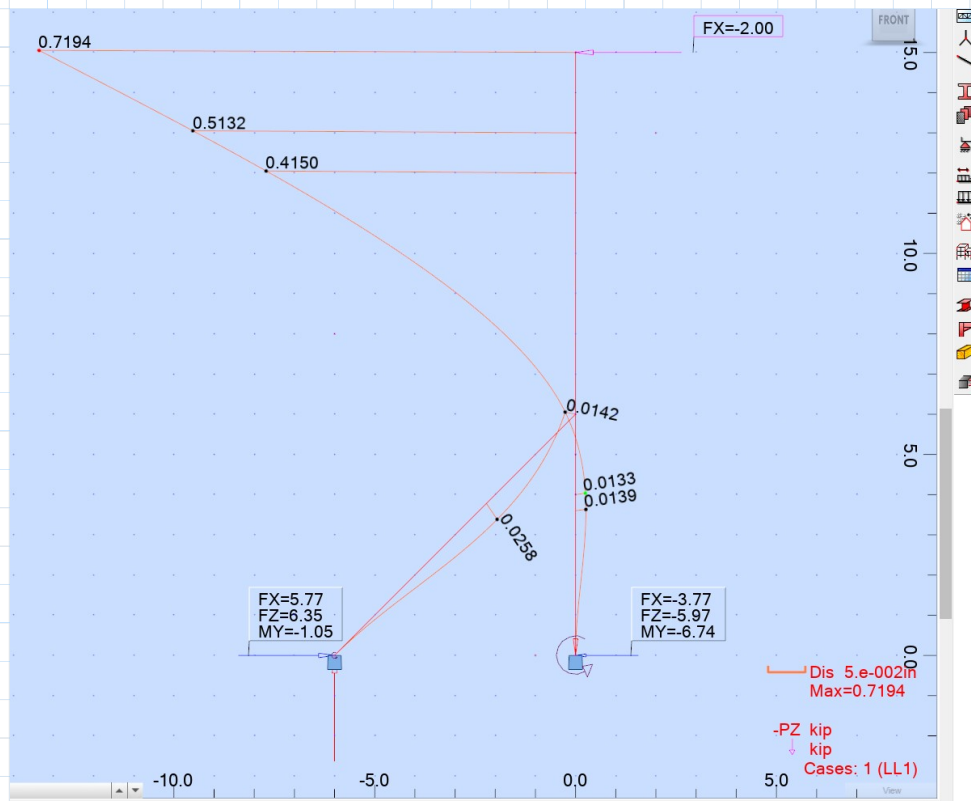
Using Robot to calculate the deflection @ Max height the deflection is 0.719 ft

Since we will be using 1 Ton hydraulic jack = 2000 lbs
We calculated it using the max (2000) at the top of the 15 ft W 8 x 18
column

since the calculated deflection is less than the allowable then the I-beam will work

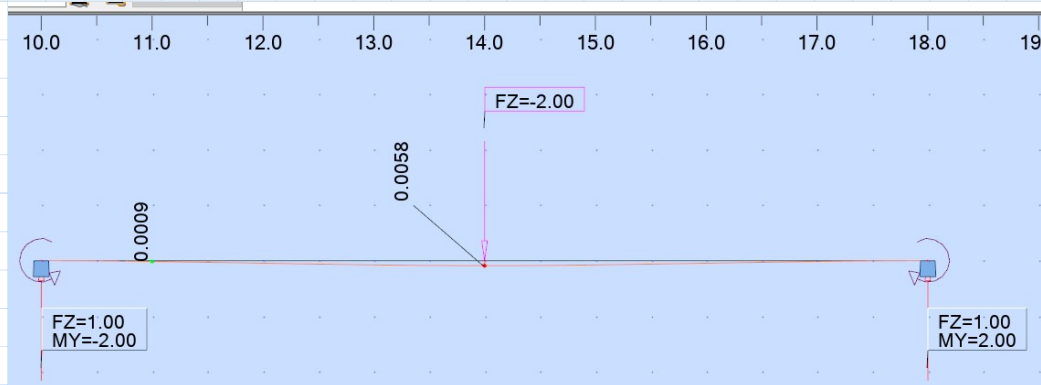
We can use the max force 2000 lbs

As you can see the Robot calculation for the deflection of 0.0058 ft
