<b>Title</b>	Cedar Prairie Pedestrian Bridge Replacement in Waterloo
<b>Completed By</b>	Lucy Dent, Michelle Nitschke, Dalton Hart, Collin Furlong
<b>Date Completed</b>	May 2021
<b>UI Department</b>	Department of Civil & Environmental Engineering
<b>Course Name</b>	CEE:4850:0001 Project Design & Management
<b>Instructor</b>	Christopher Stoakes
<b>Community Partners</b>	City of Waterloo

## Cedar Prairie Trail Bridge Replacement

City of Waterloo, IA

# Cedar Prairie Trail Bridge Replacement Report

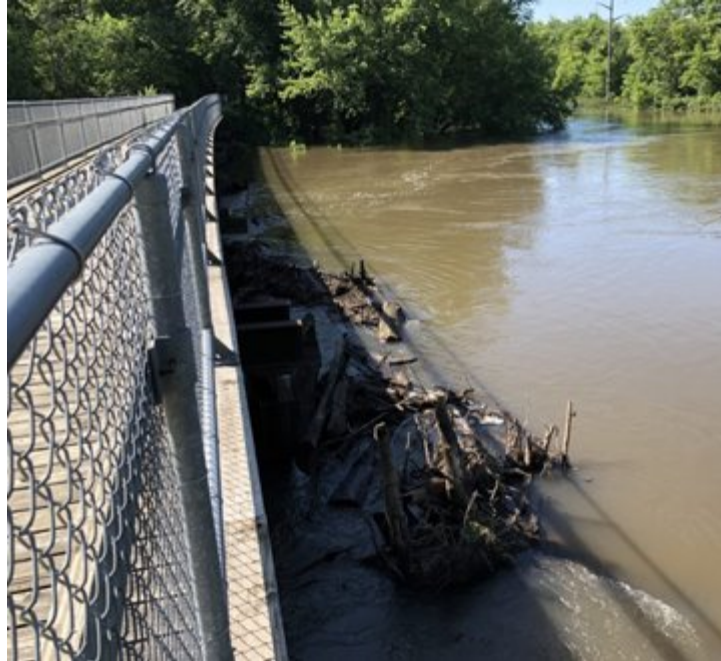
Figure 1: Debris blockage on the northern bridge during flooding

The current bridge alignments are at a significant skew to Black Hawk Creek, increasing the span length of both crossings. This causes a challenge in providing a bridge that will span the length of the creek without needing additional support to prevent failure of the bridge. Additionally, this alignment skew is contributing to a second challenge which is debris blockage. The debris blockages can be pictured below in Figure 1. The chosen alignments were selected in part for their realignment of the bridges and trail to avoid causing a similar issue.

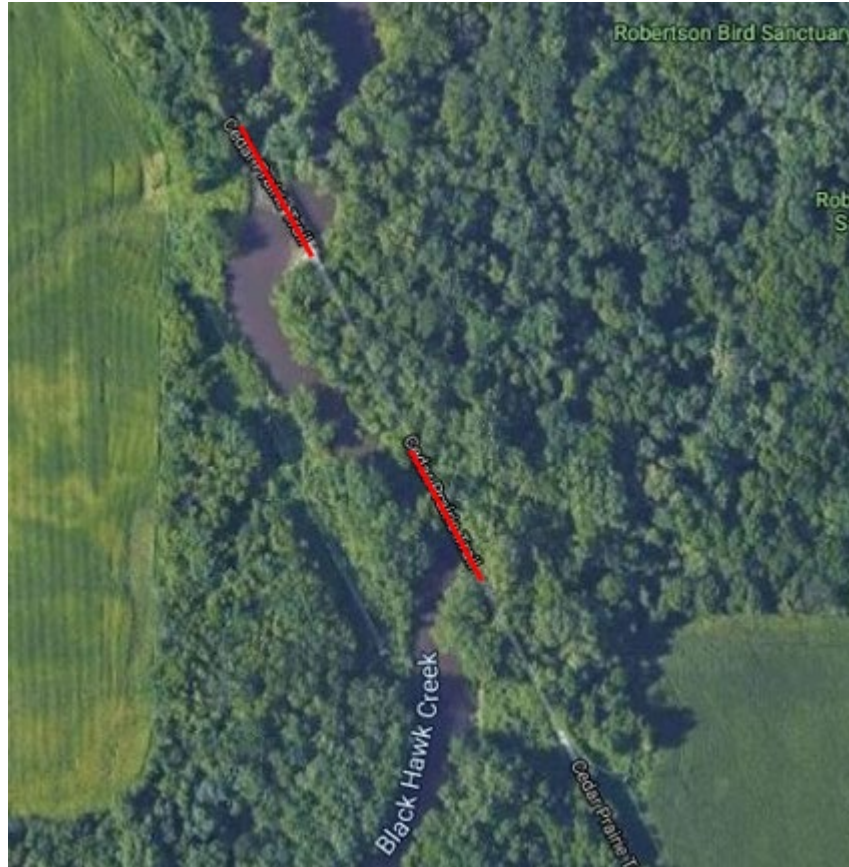
Figure 2: Alternative 1

The first design solution was to leave the two bridges in the same location as they currently stand but to replace both bridge superstructures. The locations of the current bridges are depicted by

the red lines in Figure 2 below. Leaving the bridges in the same location would have allowed the team to focus fully on the design of the bridge itself and allocate all resources to the bridge design. With this, the team could have created a design with a material that would be of very high quality that was more expensive. This would have been beneficial as that would increase the safety of the bridge as well as decrease future maintenance on the bridge. However, the current locations of the bridges are not ideal and moving the bridges were going to be more valuable than solely focusing on the bridge design and materials.

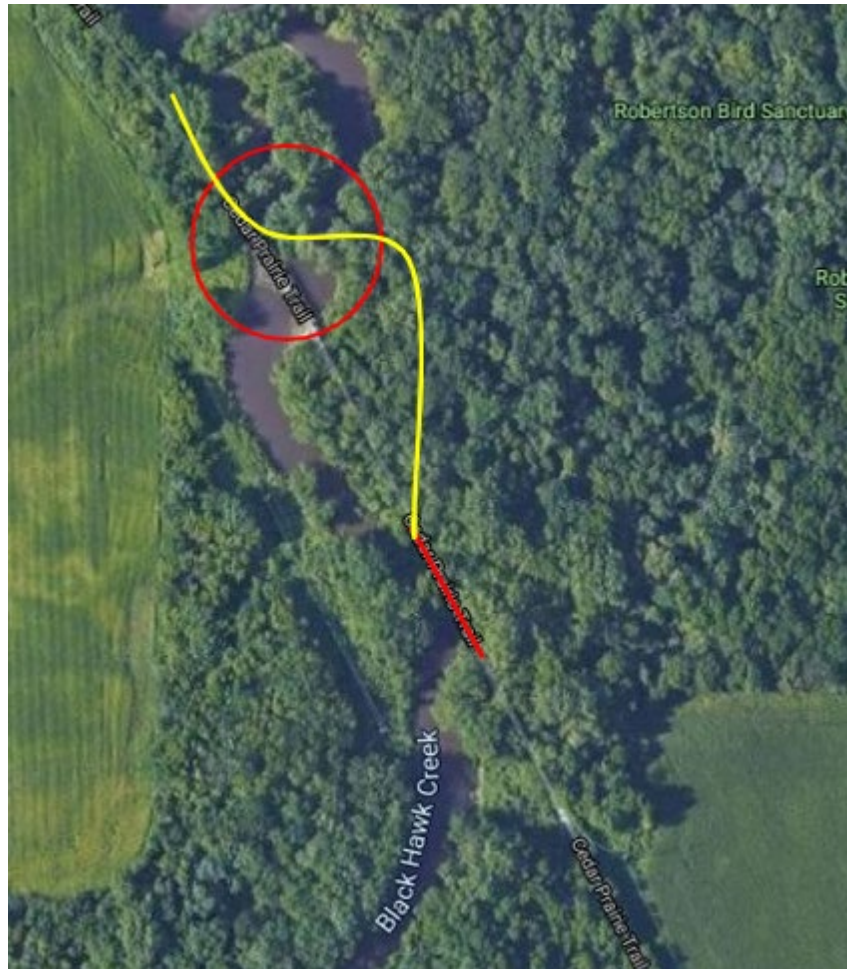
Figure 3: Alternative 2

For the second alternative solution, the design was to leave the south bridge in the same location but replace the bridge's superstructure. The north bridge, however, would have been removed and relocated but left in the same relative location. The north bridge would be realigned so that the span length is smaller, and the bridge has less skew in relation to the creek. In Figure 3 below, the yellow line depicts the realignment of the trail and north bridge. The red circle shows the general area where the north bridge would be located, and the red line depicts the south bridge staying in its same location. Shortening the span of the bridge helped make this design more intriguing, but it still left the community with two bridges which was not as ideal. It may have saved money up front to only replace one bridge, but in the long run it would add cost and required maintenance since the city would have to keep up with two bridges. Another downside to this alignment is its placement in relation to the 2-year floodplain. Going around the east side

of the creek places the trail through more of the 2-year floodplain which would increase the trail's risk of frequent flooding.

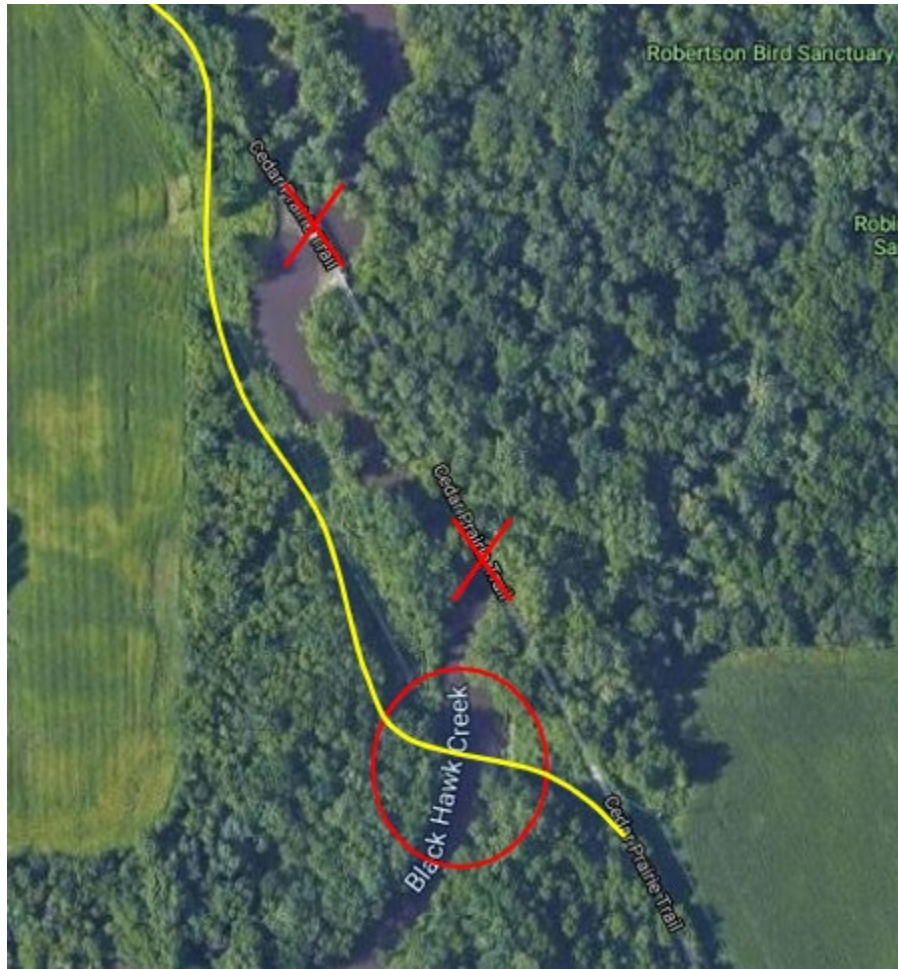
Figure 4: Alternative 3

For the third design alternative, both bridges would be removed completely. The trail would then be realigned so that the path would only require one bridge. This one bridge would be located to the south of the current crossings, as shown in the red circle in Figure 4 below. The yellow line identifies the relative location of the new trail route that stays left of the creek and crosses further south to then meet back up with the existing location of the trail. Since the team would be able to pick a new location for the bridge, they would be able to choose a location that leads to a much smaller span length that would not require any piers. This would lessen the cost of materials being used. It would also reduce future maintenance, as the city would not have to worry about piers deteriorating from debris and flooding like the current arrangement. Having only one bridge would reduce the cost of the project both up front and in the future. This also means that the team would be able to focus resources and time towards designing only one bridge rather than two. Therefore, more expensive materials and designs could be used which would increase the bridge's efficiency and safety. In addition, with one less bridge and nicer materials, there would be less maintenance in the future. Lastly, going around the west side of the creek does put

the trail in less of the 2-year floodplain which would lessen the trail's flood risk. The downside to this design, however, is the large realignment of the trail. This would increase work and cost.

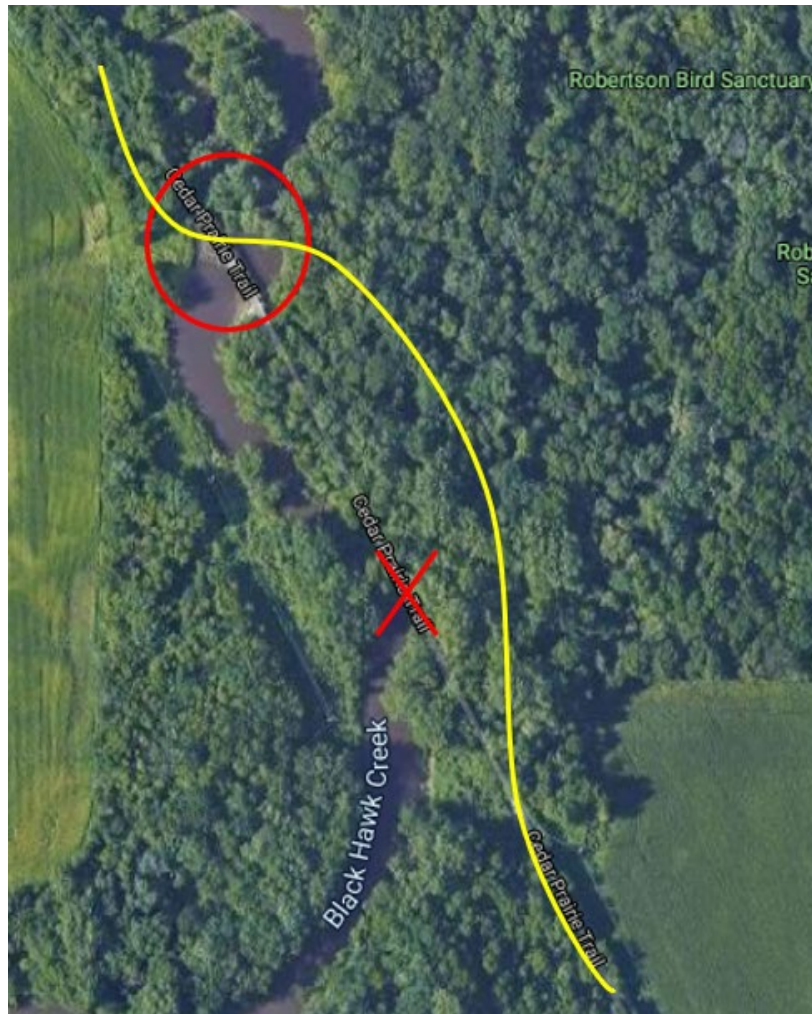
Figure 5: Alternative 4

Another design solution we considered was to remove both bridges but to replace only the north bridge. The north bridge would be slightly repositioned to lessen skew and span length but left in the same vicinity as shown by the red circle in Figure 5. With the complete removal of the south bridge, the trail would have to be realigned so that the south bridge is no longer needed. This route change is portrayed by the yellow line in Figure 5 as well. With this alternative, having only one bridge would save time and money up-front and in the future. The city would only have to pay for one bridge, and they would only have to maintain one bridge. This was a very intriguing solution for these reasons; however, this solution's realignment of the trail would create much more earthwork as it goes through a lot of trees and wooded area. As stated earlier, going along the east side of the creek places the trail through more of the 2-year floodplain which would put the alignment at a higher risk of frequent flooding.

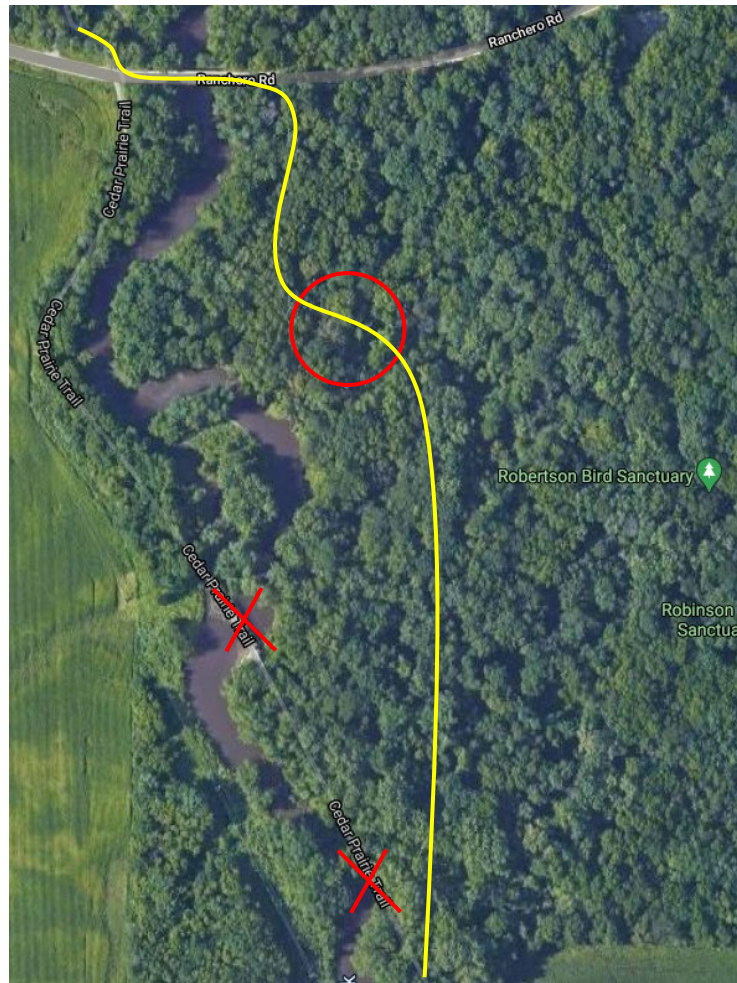
Figure 6: Alternative 5

The final design alternative considered was a complete realignment of the trail across Rancho Road and down south through the Robinson Bird Sanctuary. This involved removing both bridges across Black Hawk Creek and placing a smaller bridge across Prescott's Creek. In Figure 6, the realignment of the trail is portrayed by the yellow line and the red circle signifies the general location of the new bridge. The main advantage of this alternative was that Prescott's Creek is much thinner in comparison to Black Hawk Creek, and would require a smaller, less costly bridge. A smaller crossing would also allow for a prefabricated bridge to be used which would make construction very easy and decrease the time spent completing this project. The smaller crossing would also require much less material which would help limit costs. Along with this, having only one much smaller spanned bridge would minimize required maintenance in the future. Additionally, the new trail alignment would go through the bird sanctuary, which would create a fun recreational trail for pedestrians. However, this design would involve a total realignment of the trail with the removal of a lot of the existing trees and plants currently in the sanctuary. The work this creates would increase cost and time on the project. This alignment would also go through more of the 2-year floodplain in comparison to staying on the west side of the creek.

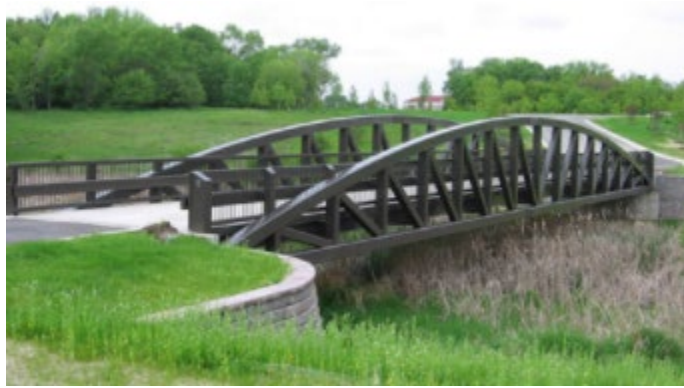
Figure 7: Keystone Truss Bridge

The shape of the truss design was highly dependent on our choice of material and the span length of the bridge. Some prefabricated designs that the team considered were a keystone truss, a link truss, and a capstone truss. Each of these designs is depicted in Figures 7, 8, and 9, respectively. If it is decided to design a truss and forgo the prefabricated option, these three truss designs can still be used as foundational ideas for the team.

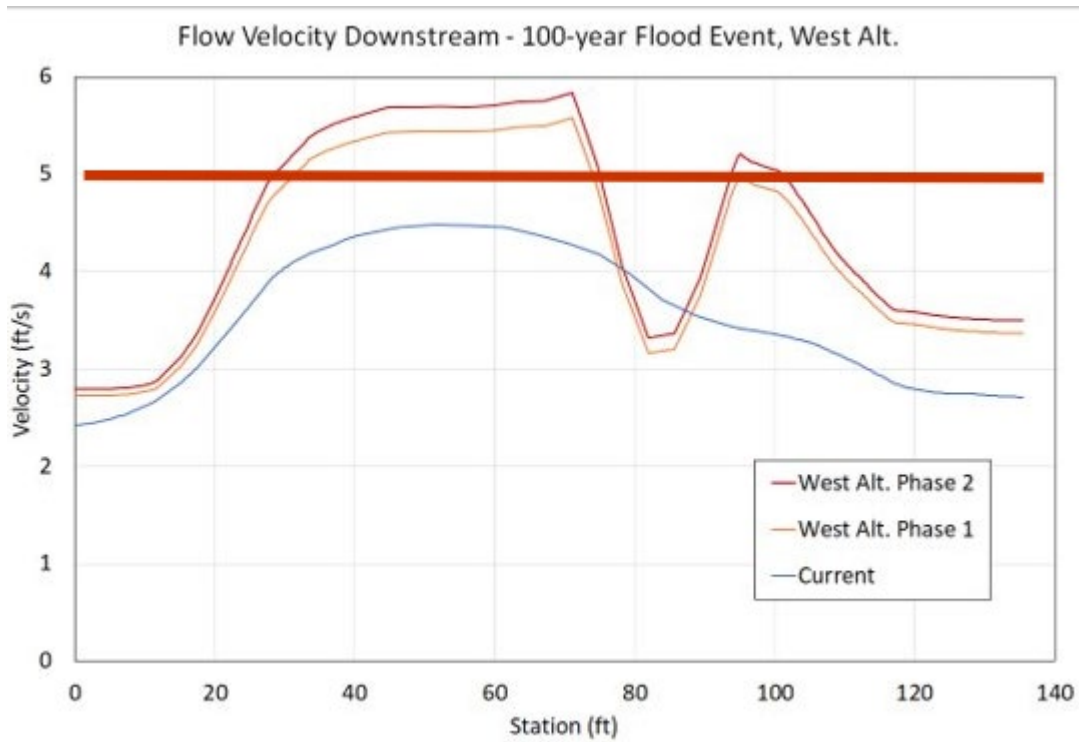
Figure 17: Velocity results downstream of the western crossing. Note the red line, indicating the SUDAS limit of 5 ft/s for a stiff clay streambed.

Results of the hydraulic analysis for the Western Trail Alignment are summarized in Table 2 and Figures 17-19. The contraction scour depth in the 100-yr event was 5.4 ft, and the peak velocity immediately downstream of the crossing was about 5.9 ft/s for phase 1 and 5.7 ft/s for phase 2. At the far upstream end of the model, we found reduction of water surface elevation of about 1 ft for both phase 1 and 2. This is approximately 1000 ft upstream of the western bridge location. These results were obtained using the methods outlined in Section 3. Note that in the 100-yr flood event, the western crossing exceeds the SUDAS limit of 5 ft/s for a stiff clay streambed, indicating a need for channel protection measures. More detailed results are provided in Appendix G.

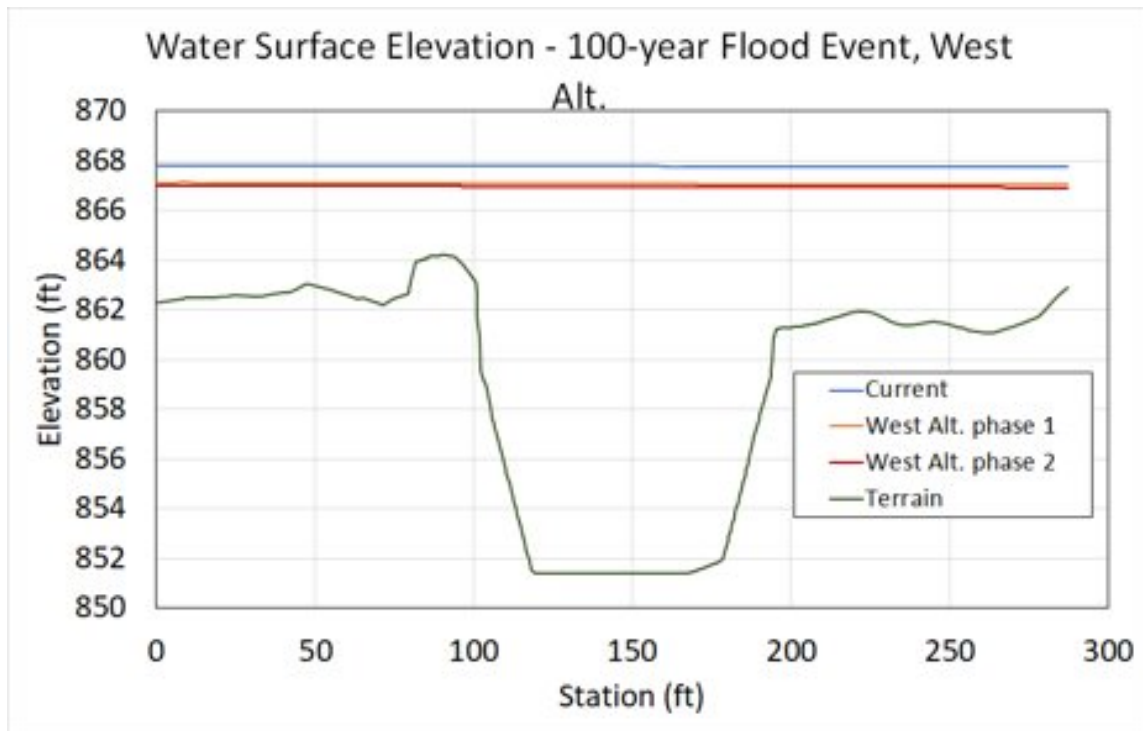
Figure 19: Water surface elevation as measured at the mouth of our hydraulic model.

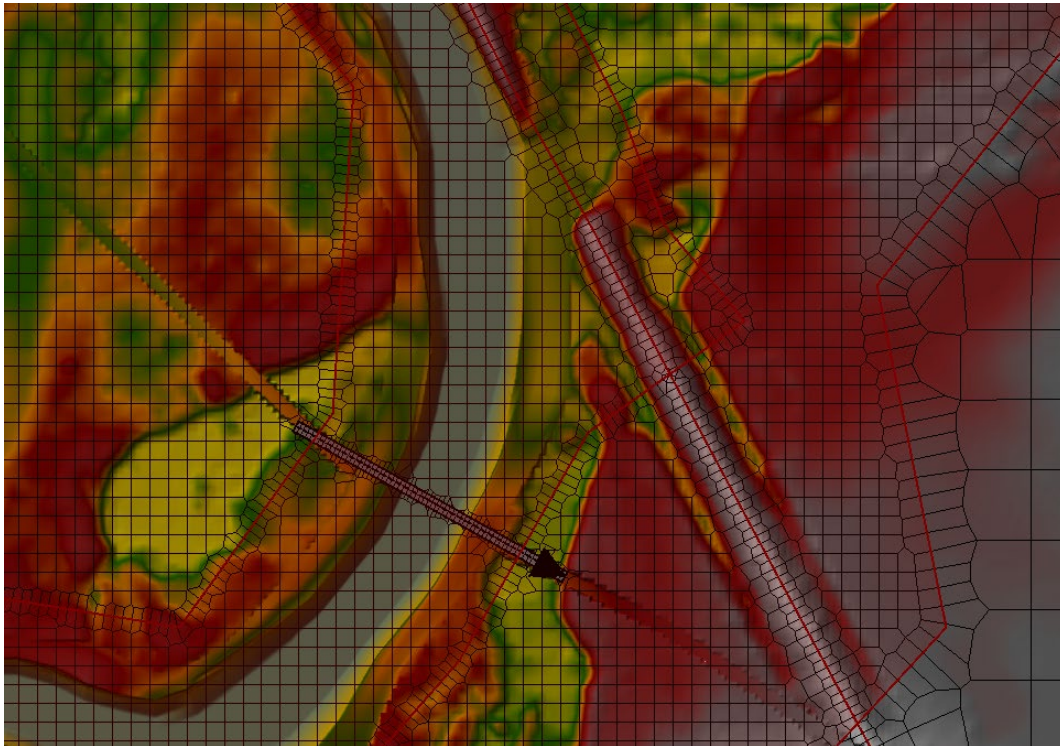
Figure 28: Western Trail Alignment showing computational mesh.

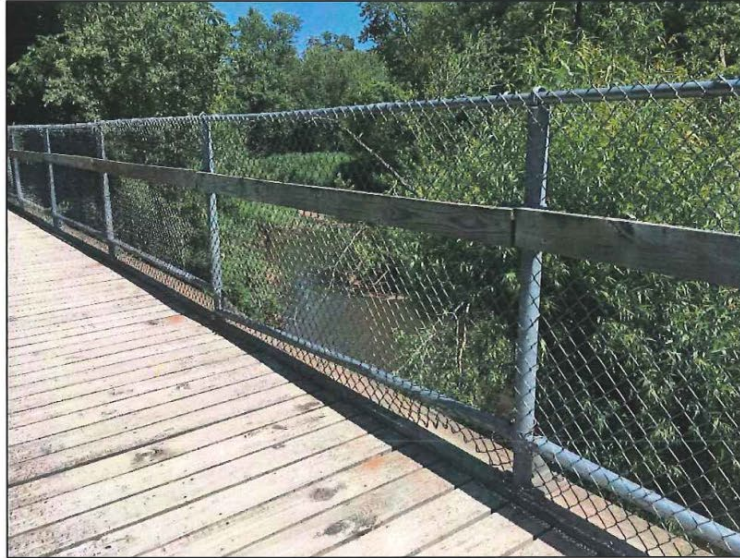
Photo Number: 7 Date: 7/12/2019  
Damaged fence member along east side, looking northeast nnn

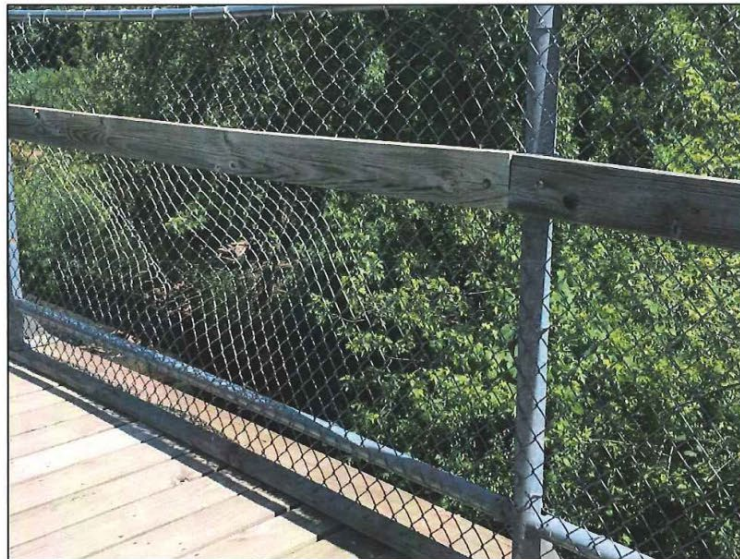
Photo Number: 8 Date: 7/12/2019  
Damaged fence along east side, looking northeast

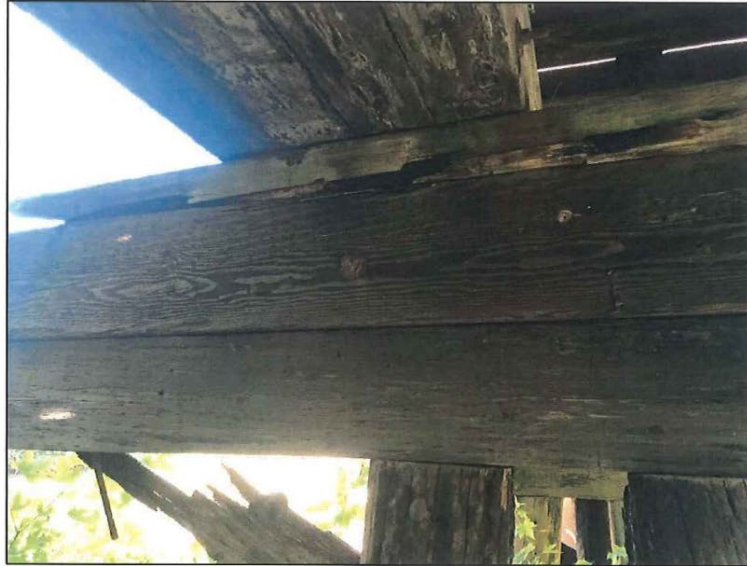
Photo Number: 13

Pier 1 looking north with decayed timber cap and missing pile

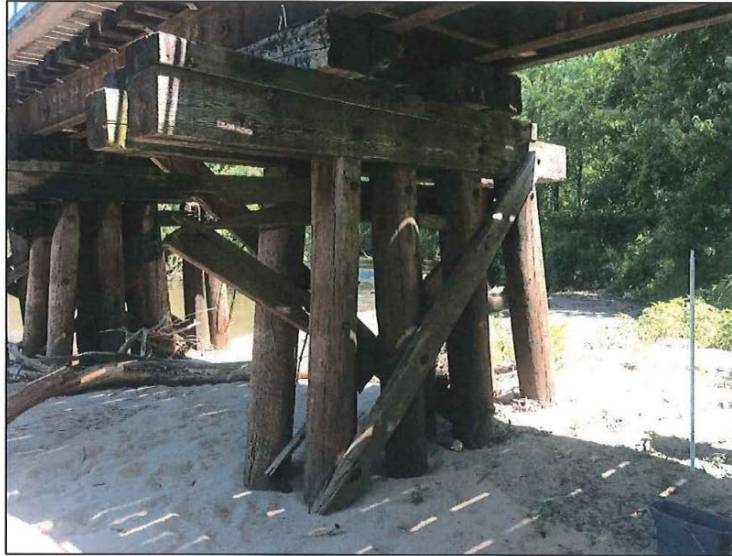
Photo Number: 17 Date: 7/12/2019  
Pier 3 looking NE, with two piles missing from north and south bents

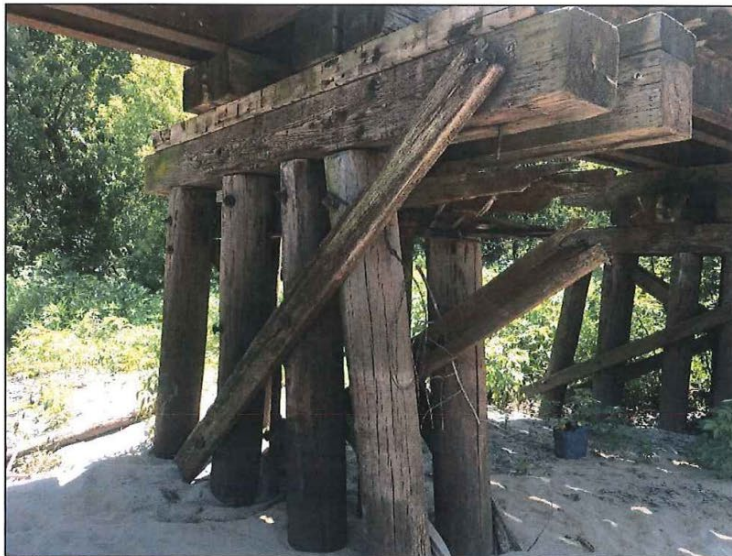
Photo Number: 18 Date: 7/12/2019  
Pier 3 looking SE, with two piles missing from west ends of north and south bents

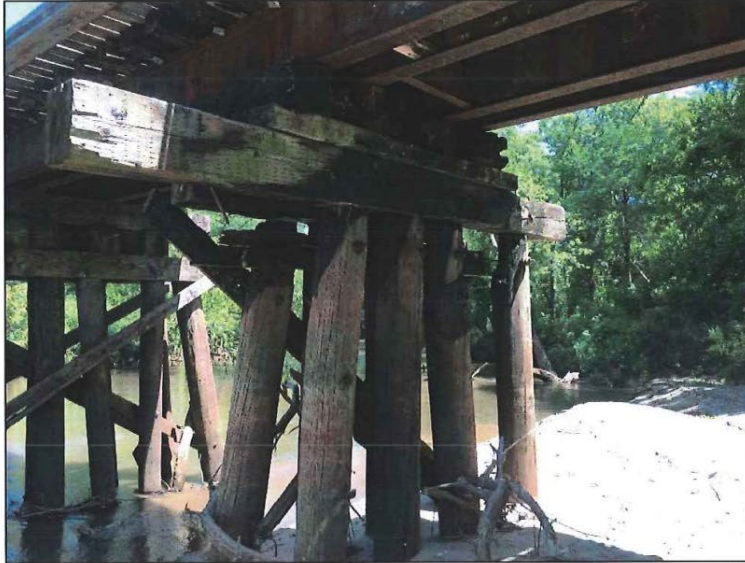
Photo Number: 19 Date: 7/12/2019  
Pier 4 looking NE, with two piles missing from the west end of both bents, and fire char on remaining piles and cap

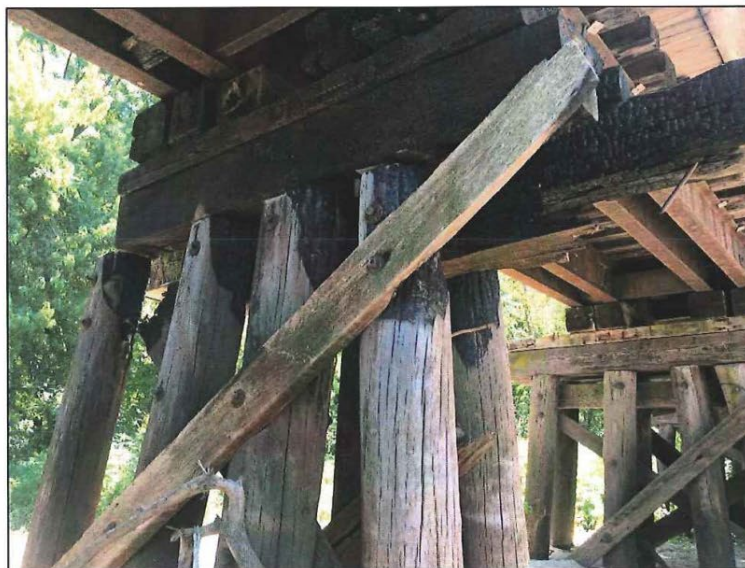
Photo Number: 20 Date: 7/12/2019  
Pier 4 looking SE with missing piles at right and severe char on upper piles and cap

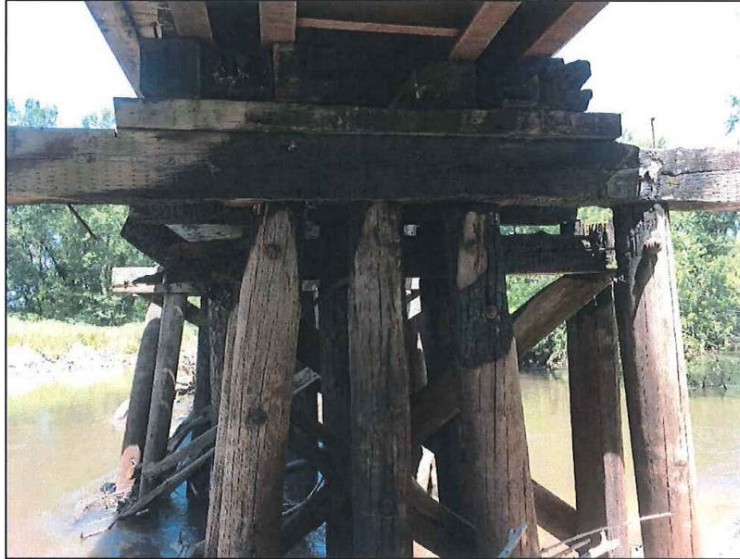
Photo Number: 21 Date: 7/12/2019  
 Pier 4 looking north showing missing piles at left and fire char at cap

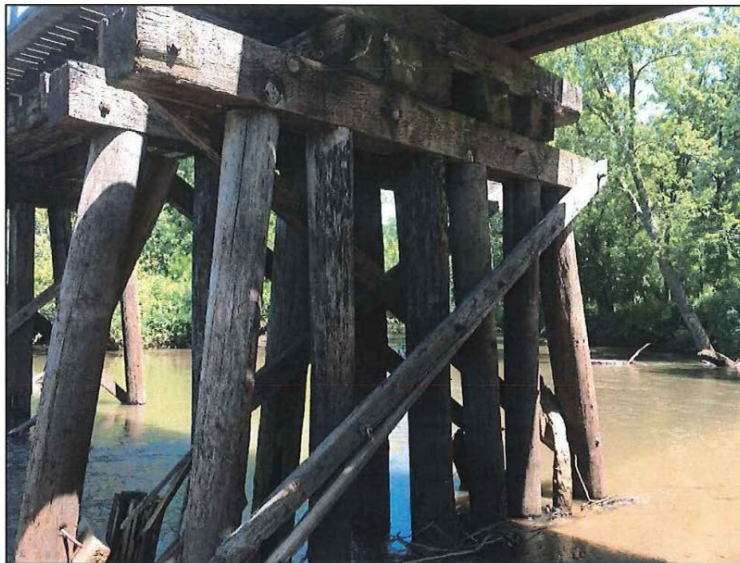
Photo Number: 22 Date: 7/12/2019  
 Pier 5 looking NW, with pile at far left exhibiting a large split

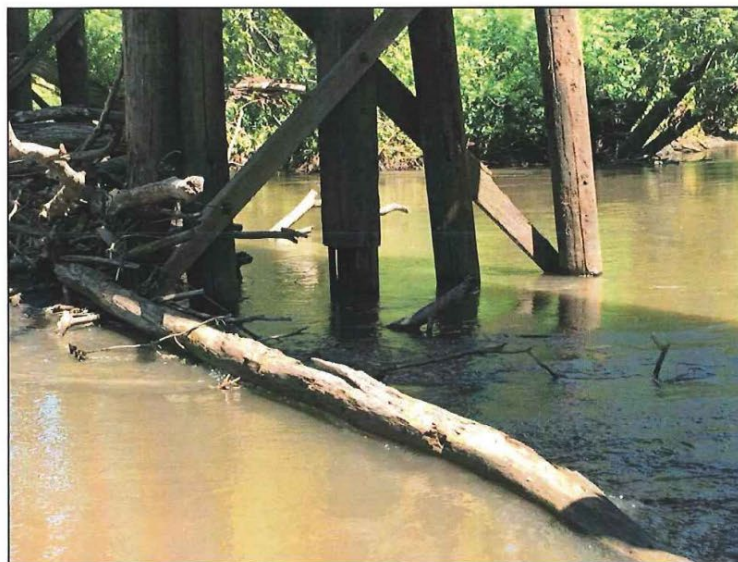
Photo Number: 24 Date: 7/12/2019  
Close-up of base of Pier 6, with severe timber decay and partial timber splice visible at waterline

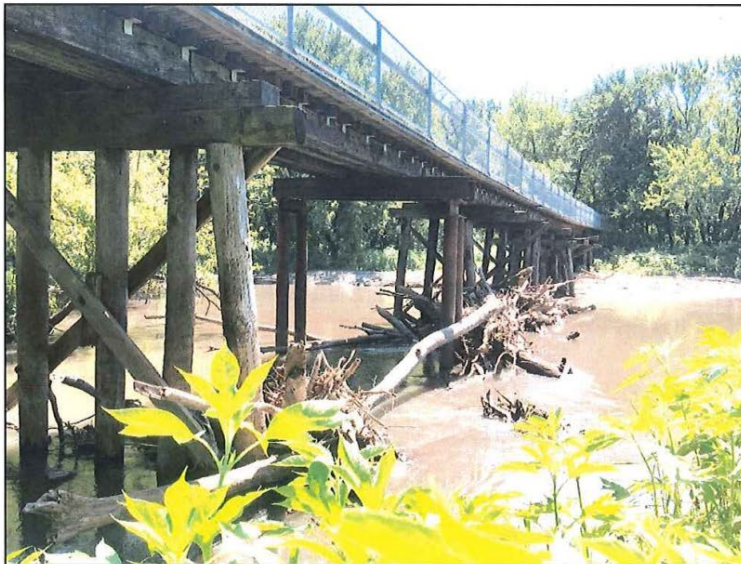
Photo Number: 26 Date: 7/12/2019  
Timber pile bent Pier 9 at left, and steel pile bent Pier 8 in channel, looking south

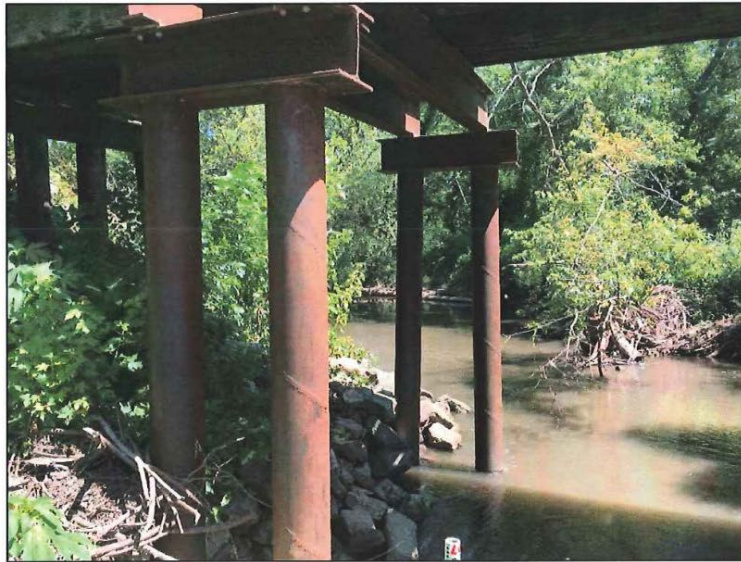
Photo Number: 28 Date: 7/12/2019  
Steel pile bent Pier 10, looking NE

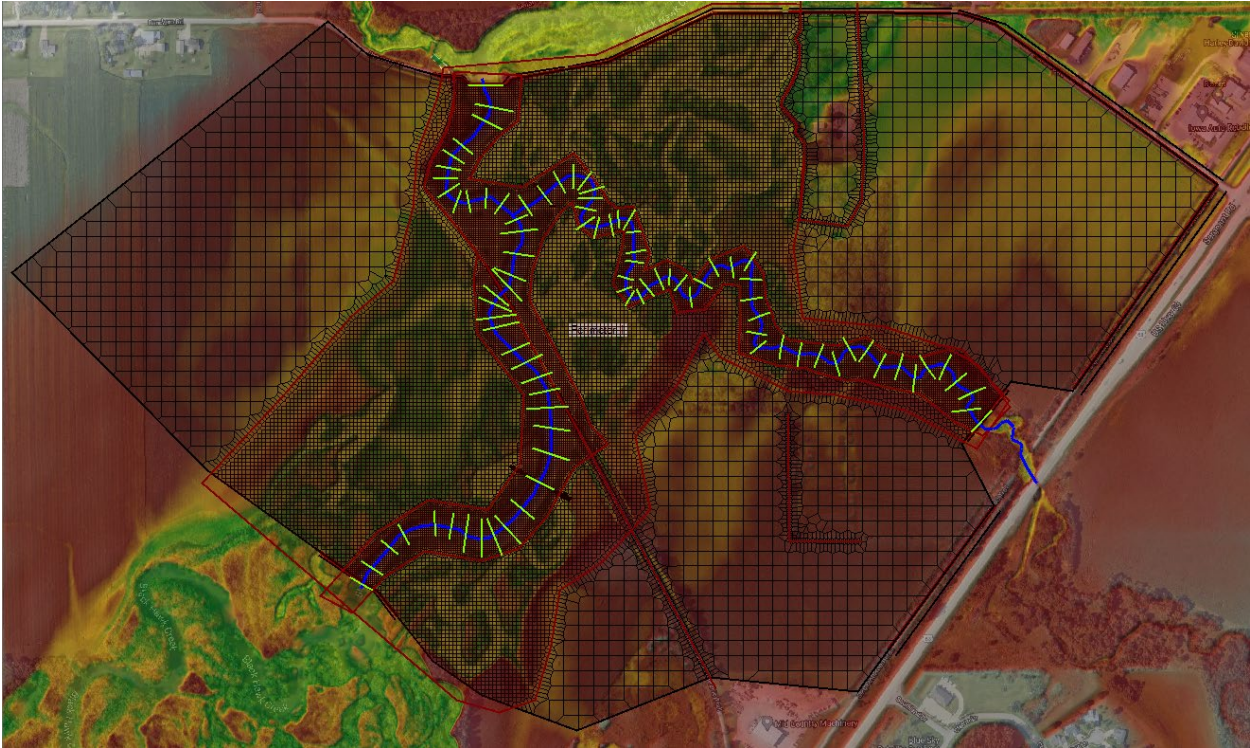
Figure 29: Model showing computational mesh with breaklines, refinement regions and boundary condition lines, as well as cross-sections used to create channel modifications
