Chadek Property Community Garden Soil Investigation

Soil Genesis and Geomorphology
Class Project, Fall, 2014

Department of Earth and Environmental Sciences
The University of Iowa, Iowa City, IA 52242-1379, USA

12/11/2014

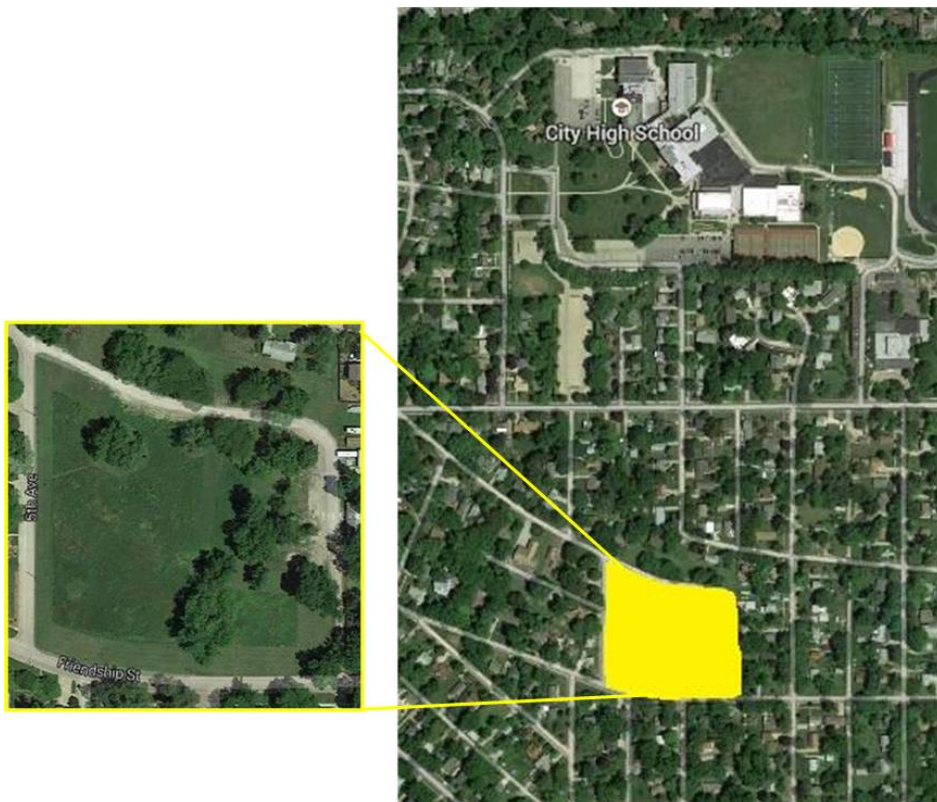
Figure 1. Location of the Chadek property in relation to City High at the top of the right image. The inset image shows the current layout of the property with Friendship St. to the south and 5th Ave. to the west. Aerial photos (2013) from Johnson County Property Viewer¹.

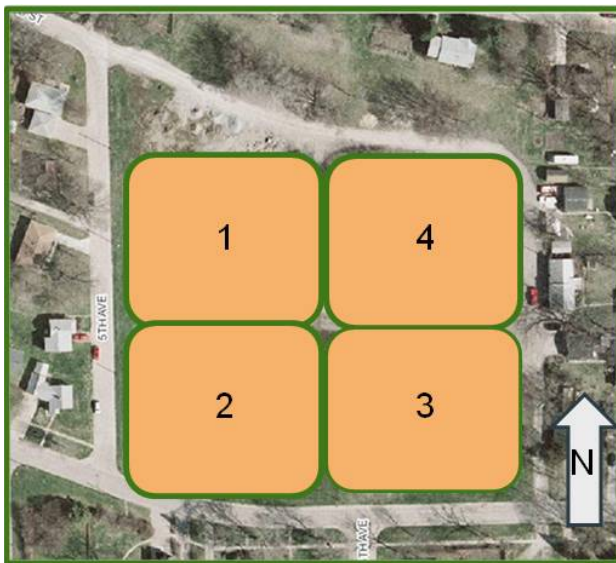
The property was divided into 4 quadrants and each quadrant was assigned to a group of students (Fig. 5). Each group assessed their quadrant, taking core samples with a coring tool, and digging holes to get a better look at the subsurface to identify and describe the soils present. The cores were used to provide quick soil descriptions and characteristics to get an overview of the quadrant and sub divide accordingly. Once the sites of interest were determined, holes were excavated by hand to depths of 40-60 cm to further investigate the detail of the soil horizons and other features (charcoal, bricks, etc.; Fig. 6). Bulk density samples (collected in 3 inch tall, 3 in. diameter aluminum cylinders) and soil samples were also taken from the sites, which were further examined in the lab at a later date.

Figure 5. Shows how the property was divided into 4 quadrants.

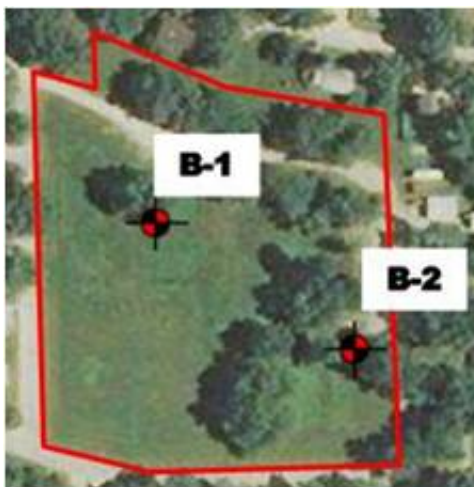
A limited site investigation (LSI) was conducted at the site in September, 2014 by Terracon, Inc. They took two soil borings in two different areas of interest on the site (Fig. 7), not only to take samples and tests to document lithology, color and moisture content, but more importantly, to test the soil for volatile vapors/compounds(VOCs) and Resource Conservation and Recovery Act (RCRA) metals and contaminants.

Figure 7. Image showing the location of borings where Terracon took samples during the Limited Site Investigation.

According to the LSI report made by Terracon, all RCRA metals are below state wide standards. However, there is a relatively high concentration of waste oil at boring 2, B-2, and traces of other RCRA metals in B-1 (Fig. 13). This could be expected though, because boring site 2 is known to have been used as a parking space and boring 1 is the approximate location of the old coal burning furnace that powered the original factory. Other than that, their assessment indicated no areas of concern on the property.

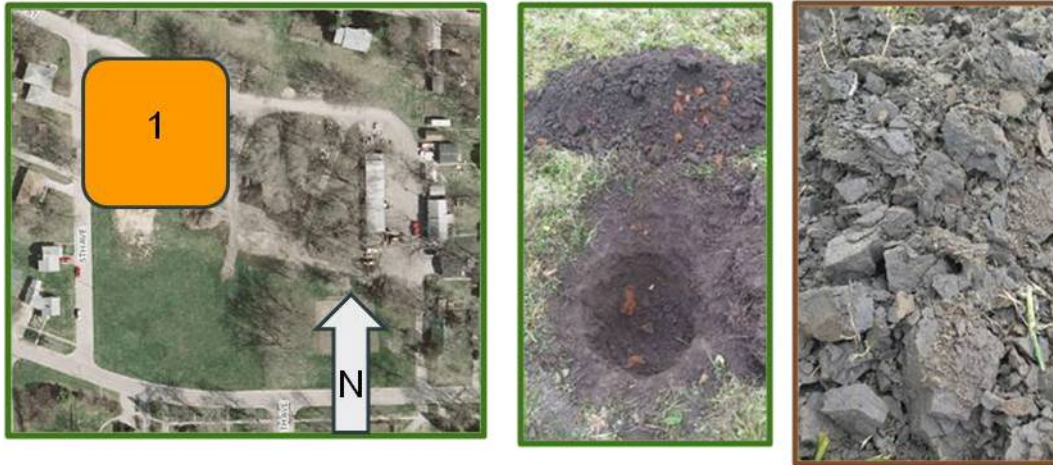
Quadrant 1, located in northwest section of the property featured soil that was heavily compacted throughout the majority of the quadrant. Large amounts of fill were present throughout, adding to the soil's compaction, and making it difficult to obtain soil profiles in this area. Cement or brick fill was found between 5-15 cm depth in every location examined. Much of the southwestern half of the quadrant contained a cement/limestone pad remaining from the original 19th century factory building, lying just inches under the surface, as well as bricks and other artifacts from the production and storage of materials on the site (Fig. 8).

Figure 8. Images showing the location of Quadrant 1, bricks and other artifacts found in the soil, and the heavily compacted soil characteristic of this part of the property.

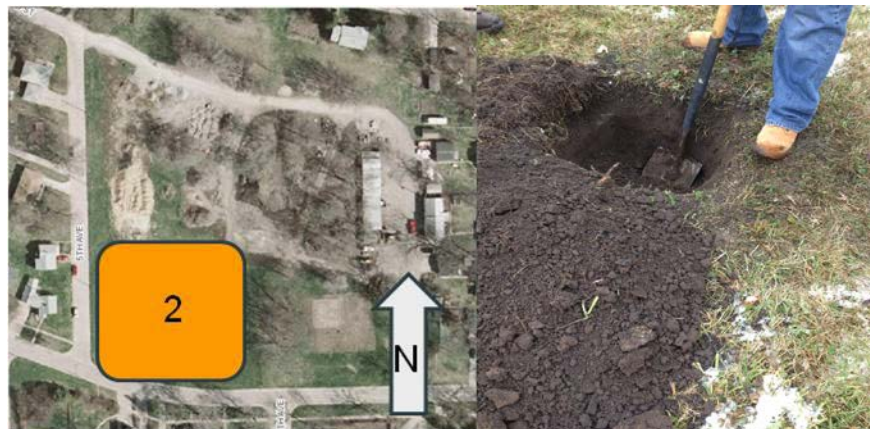
Quadrant 2 was located in the southwest corner of the property (Fig. 9). Soil was compacted along the western street side, where it appears to have been mowed more regularly and has witnessed more pedestrian traffic. Horizons throughout the quadrant were clearly defined and included thick, silt loam topsoil horizons with silty clay loam subsoil horizons, much like the Web Soil Survey indicated. The topsoil horizon was much thicker in the southeast portion of quadrant 2. Also in the southeast corner, a thin surficial layer of rubble was encountered. This did not really affect the overall quality of the topsoil, however.

Figure 9. Images showing the location of Quadrant 2 and the relatively healthy soil that is found there.

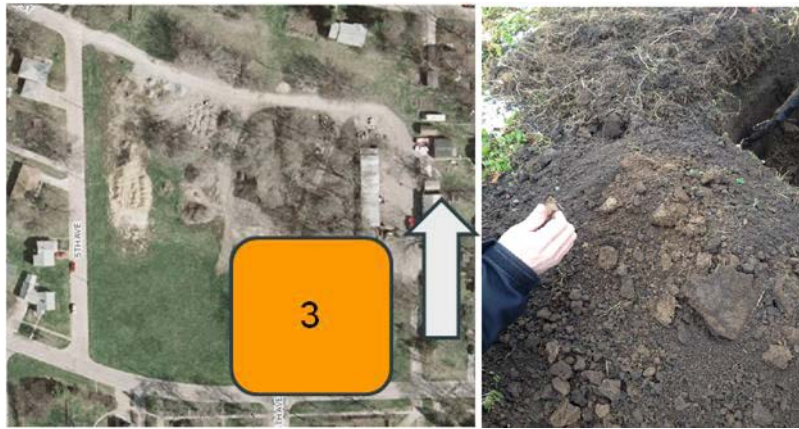
Quadrant 3 is located in the southeast section of the property (Fig. 10). 3 soil units were recognized in this area. Unit A was decidedly the healthiest soil unit, as it was the least compacted, including a silty clay loam topsoil, underlain by a clayey subsoil horizon. Unit B similarly displayed topsoil with a silty clay loam texture underlain by a more compacted clay loam subsoil horizon. Unit C was our most compacted soil and we were unable to penetrate past 10 cm of gravel/fill. Our last sample was located in the southeastern corner of the

quadrant. We believe it to be part of Unit 3, though it does have slightly different properties and was less compacted. It included small quantities of charcoal and pebbles.

Figure 10. Images show the location of Quadrant 3 and the relatively healthy soil that is found in the central and western part of that quadrant.

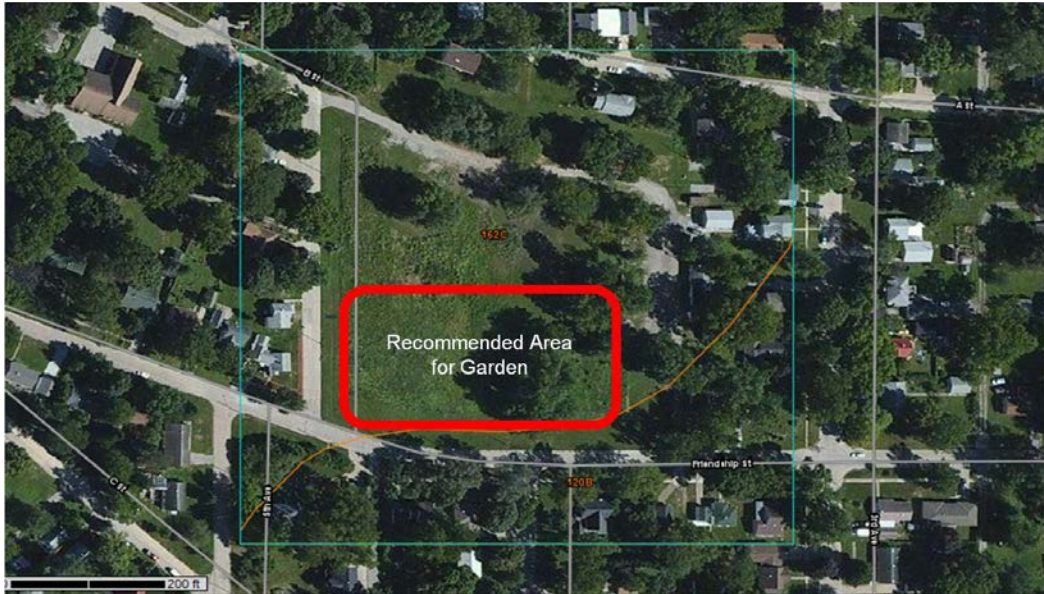
In this document, we feel we have presented sufficient evidence to support our recommendation for what we believe to be the most suitable part of the property for a community garden. Due mostly to the fact that the northern half of the property is highly compacted and contains a large amount of fill and debris, and also due to the higher risk of contamination from waste oil and RCRA metals in certain locations, the area most suitable for a community garden is the southwest quadrant (Q2) of the property and the western 2/3 of the southeast quadrant (Q3) (Fig. 14).

Figure 84. Recommended area for a community garden on the Chadek property, restricted mostly to the south and southwest portion of the property.

The only part of the southwest quadrant that might not be quite as suitable would be the narrow stretch along the streetsides that is slightly more dense and compacted, possibly due to it being mowed more frequently. The area to avoid in the southeast quadrant is the northeast part, where there is a higher risk of contamination from waste oil, according to the LSI analysis and along the alley where gravel and compaction will restrict use as a garden. Other than these two exceptions, this portion of the property is the most similar to the prime farmland soil series listed on the Web Soil Survey database.

While it is likely to be the best area for a garden on the Chadek property, the soils in the recommended area would still need to be amended to successfully accommodate gardening needs. On average, Nitrate, Humus, Potassium and Magnesium are low on that portion of the property. In order to enrich the soil, we recommend that the City of Iowa City add compost. The Addition of compost would raise the level of Nitrates, Humus and Magnesium in the soil, making the area perfect for gardening.
