Title Keokuk Downtown to Riverfront
Connection Engineering & Design

Date Completed May 2020

Course Name Senior Design - CEE:4850:0001

Downtown to Riverfront

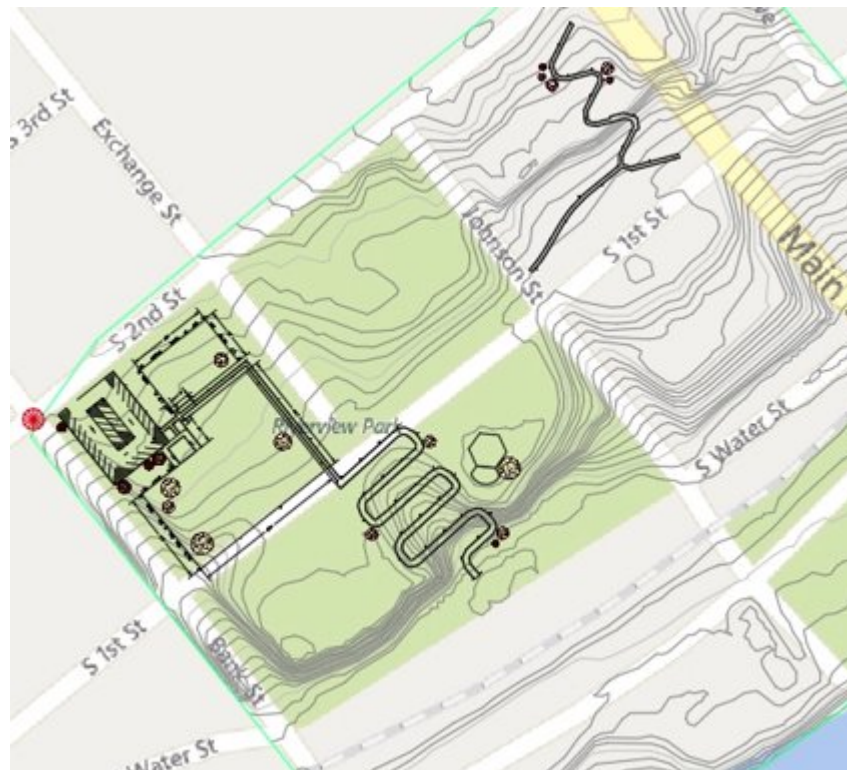
The first aspect of the site design was the placement of the various park amenities. This included the trail on the southwestern side of Highway 136, the trail connecting Gateway Park to Riverview Park, the trail providing access from the top of the bluff to the Union Depot, the large and small dog parks, a gazebo and viewing area, a bathroom and storm shelter structure, a parking lot, and a trail within the park to connect all these. The final placement of these can be seen below in Figure 1.

Figure 1. Site Design Illustration

Also included in the site design is the proposed landscaping plan. This encompasses both vegetation, such as trees and shrubbery, as well as lighting. It was determined that to best provide the desired shade throughout the park, deciduous trees would be used. Using the Iowa DOT's Guide to Common Trees and Shrubs of Iowa, the suggested trees for this are: Red Maples, Silver Maples, Bur Oak, and Pin Oak. Determination of the best trees for this project site should be based on the soil classification and moisture level, which were not available to the team. Around the parking lot, coniferous trees were placed to provide year-round shade to parked cars. It is recommended that evergreen trees be used for this purpose. Around the outer perimeter of the dog park fence, it is suggested that shrubs be planted to improve the aesthetic appeal. It is suggested that Grey Dogwood shrubs be planted. These are commonly used for hedges and buffers in urban settings and are non-toxic to dogs. Not included in this landscaping plan, but also suggested, is the planting of perennials along the length of the trails.

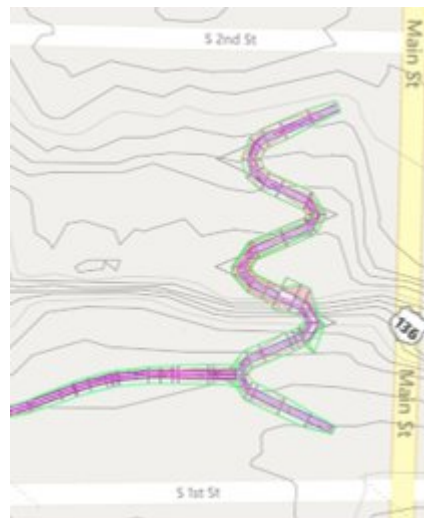
The trail on the southwestern side on the highway was created to help connect the downtown area to Riverview Park. The trail was given tight constraints on both sides; one by the highway and the other by local business-owned property. Given these boundaries, the trail would need to stretch from the intersection of Highway 136 and North 2nd Street down to South 1st Street. The land area outlined in the plan has a section of the trail in which the slope is steep; failing to offer a safe trek without the fear of falling was a priority in the design. As a design team, we decided that a switchback trail was the best way to navigate down the hill for the residents. The trail designed has 5 switchback curves with each curve radius averaging at approximately 15 feet. This radius was chosen to effectively move down the hill, but to also be mindful of increasing slopes. This trail has a slope of 5.45 % downward for the entire length of the walking trail. Since the slope is less than 6%, it is allowable to run any distance according to the ADA Accessibility Guidelines. The trail was created on Autodesk Civil 3D. See Design Drawings for the more detailed plans of the Highway Trail.

Figure 2. Highway Trail Illustration

Off the last switchback, there is a trail that connects the trail to the corner of South 1st Street and Johnson Street. This trail does not exceed a 2% slope, which meets ADA Accessibility Guidelines for maximum running slope. Its path leads through the church's unpaved parking lot, so that residents utilizing the trail can easily follow it to Riverview Park to enjoy the other amenities designed in this project. The trail is 5 feet wide concrete with bricks lining both sides and the length is about a tenth of a mile long. Materials for this trail were a PCC slab on grade with a ¾" crushed stone subbase and brick edging, which mimics the existing Gateway Park trail.

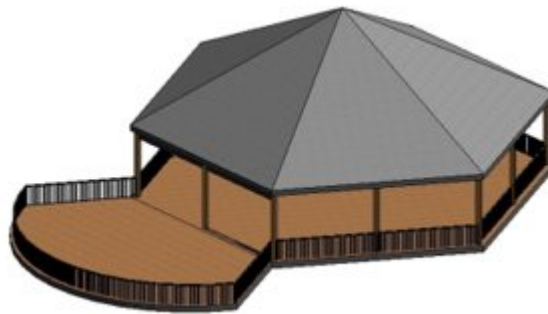
A gazebo was designed provide an aesthetic appeal and a shaded seating area for people who visit the park. This gazebo was designed using architectural design tools in Revit. Audodesk Robot was used for structural analysis of the designed gazebo. The shape of the gazebo was chosen to be hexagon to add uniqueness to the structure. The gazebo also has an unshaded deck area connected to one side of the hexagon. This deck overlooks the union depot trail as well as the union depot and Mississippi River.

Figure 7. Gazebo Illustration

The location of the gazebo was chosen to be on the North East part of the park so that it has the best site lines over the trail and down to the union depot and river. Under the shaded area there are picnic tables for visitors to enjoy and use. The gazebo was designed to be built with a concrete slab foundation, but wood decking is used on top to match the wood trend throughout the rest of the gazebo. The concrete slab was designed to be 6 inches thick which meets and exceeds the requirements for ASCE Building Codes 3-19. The columns, beams, and railings are also made of wood. The National Design Specifications for Wood Construction was used for the design of the columns, beams, and roof. The roofing material chosen for this structure was asphalt shingles which will be the most cost effective while also maintaining the overall aesthetic of the gazebo.

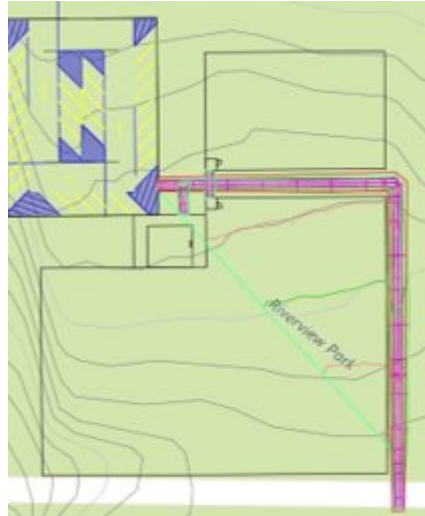
The main connecting trail joins the parking lot to the other sections of the park, including the restroom structure with a storm shelter, the entrances to the dog parks, and the walking trail down to the Union Depot. These connecting trails were designed to put the visitors of Riverview Park at ease.

Figure 8. Connecting Trail Illustration

As a design team, it was imperative to make practical connections with the other amenities in the park. The main part of the trail runs in between the two dog parks from the southeastern corner of the parking lot. At the entrances to the dog parks, the trail has sections that extend to the outer gates. The main trail runs continuously to the corner of the park and turns southward to intersect the Union Depot trail. The trail is 5 feet wide concrete with bricks lining both sides and the length is about a tenth of a mile long. Materials for this trail were a PCC slab on grade with a $\frac{3}{4}$ " crushed stone subbase and brick edging, which mimics the existing Gateway Park trail. The trail was designed in Autodesk Civil 3D – See Design Drawings Sheet No. 14-19 for the complete Connecting Trail drawings.

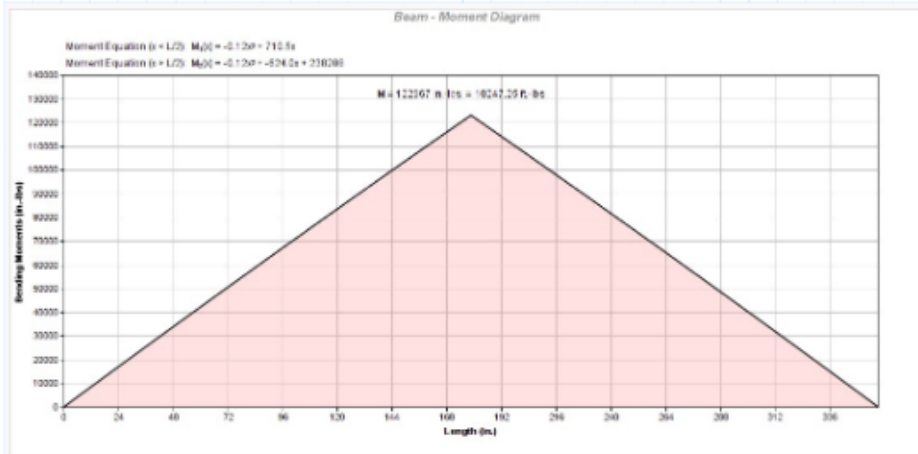
beam design:

Beam Data	Design Loads	Design Options	Design Assumptions
Load Type: Single Point Load Support: Simple Beam Beam Type: Sawn Lumber Species: Douglas Fir-Larch Grade: DF Construction Size: 4 x 4 Design Span (L): 28.75 ft. Clear Span: 28.50 ft. Total Span: 30.00 ft. Bearing (l _b): 3 in. Quantity (N): 1	Live Load: lbs Dead Load: 1304.5 lb Selfweight: 88.6 lb Dist. Selfweight: 2.91 plf Total Weight: 87.3 lb	Lateral Support: braced Def. Limits: 180/120 Load Duration: 1.33 Exposure: dry Temperature: T <= 109°F Orientation: Vertical Incised Lumber: No Rep. Members: No	Code Standard: IBC 2015, NDS 2015 Bending Stress: Parallel to Grain Notes:

each column should stand 710.53lbs at each end of beam.
 footing design:
