Mutchler Community Center

Bloomfield, IA

Section I | Executive Summary

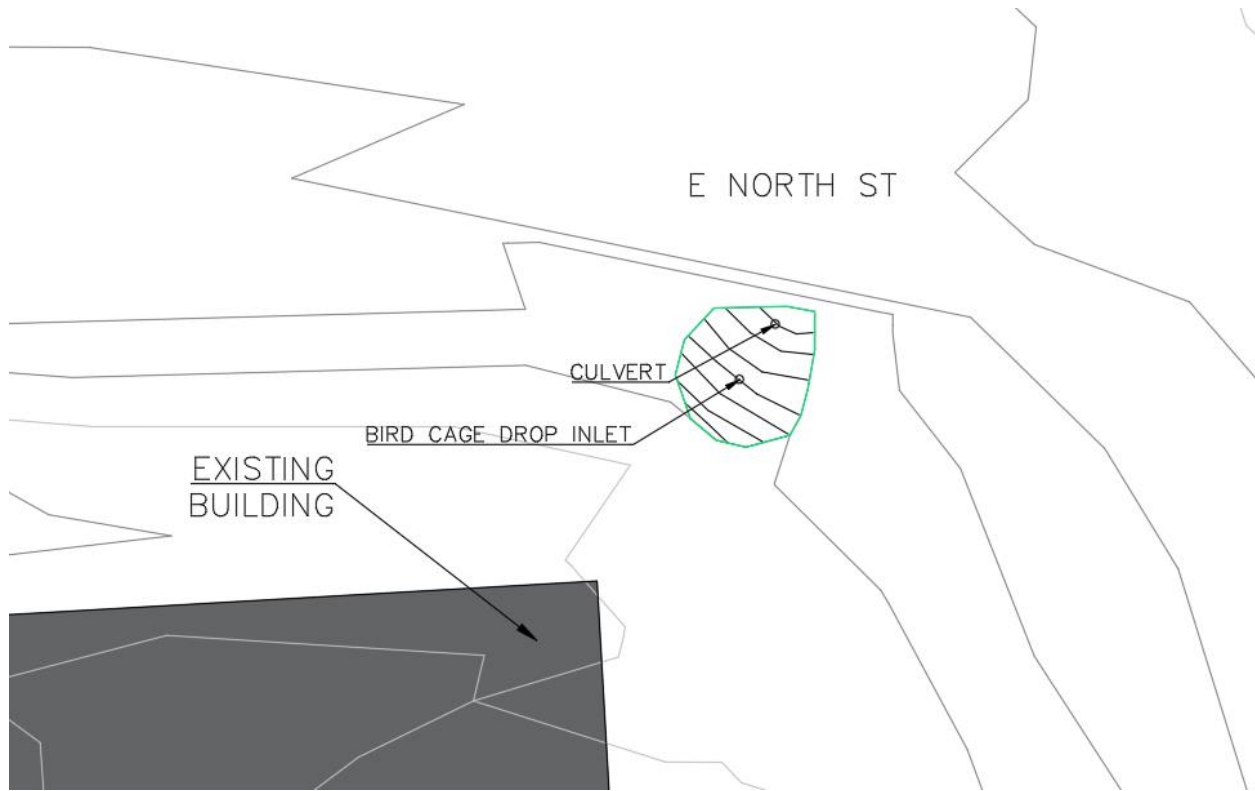
Figure B.1: Proposed Updated Drain Surface

- 1) **Divert Source of Erosion** – The significant amount of the overland flow of water is coming from the culvert to the north of the community center. Redirecting that flow could significantly reduce the erosion.
Lowering the elevation of the current storm drain that is not capturing all the water through the culvert would reduce erosion. Existing grades would remain the same. This is an inexpensive alternative, but this would not account for the flow coming from neighboring properties and areas to the south of the drain so there is a possibility of erosion still occurring.
