Downtown to Riverfront

Keokuk, Iowa

SAZA Consulting

Section I Executive Summary

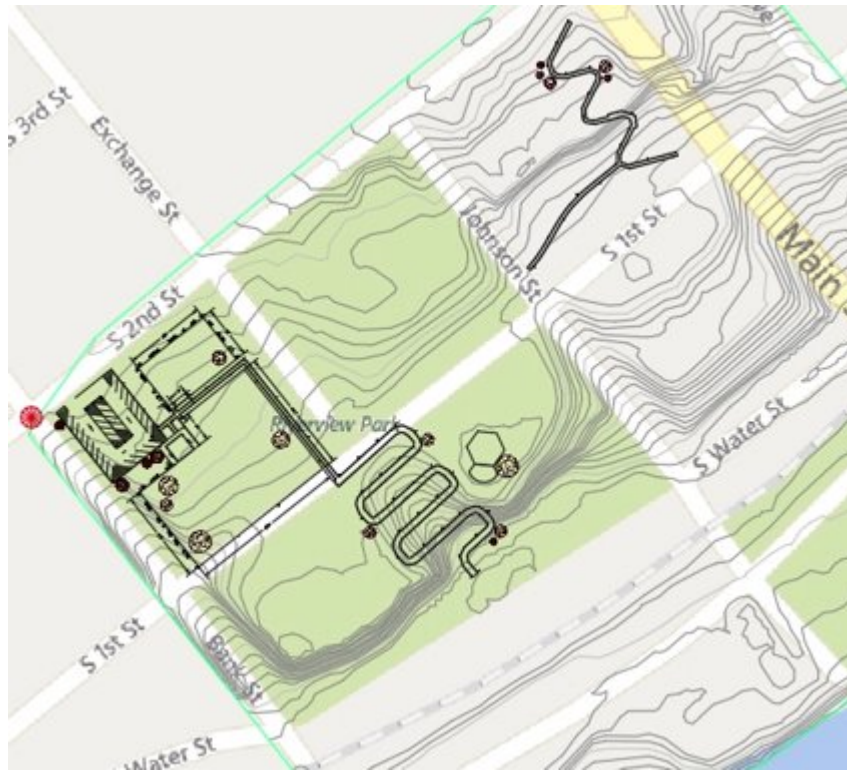
Figure 1. Site Design Illustration

The first aspect of the site design was the placement of the various park amenities. This included the trail on the southwestern side of Highway 136, the trail connecting Gateway Park to Riverview Park, the trail providing access from the top of the bluff to the Union Depot, the large and small dog parks, a gazebo and viewing area, a bathroom and storm shelter structure, a parking lot, and a trail within the park to connect all these. The final placement of these can be seen below in Figure 1.

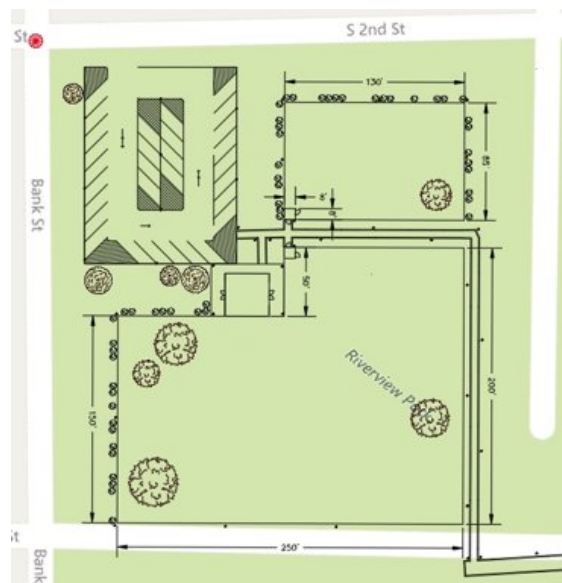
Figure 6. Dog Park Illustration

In accordance with typical dog park design standards, the large and small dog parks were designed to be one acre in area and a quarter of an acre in area, respectively. To best utilize space and limit required grading, the dog parks were placed in the northwestern quadrant of Riverview Park, near the parking lot. The large dog park was designed in an L-shape, and the small dog park was designed to be a rectangle. A 20-foot space was left between the two parks to allow for a trail that would allow owners to observe their dog(s) from the outside.

Along the perimeter of the dog parks it was determined that a 5-foot-tall galvanized steel chain link fence would be used, as is standard practice. This is the minimum height required for most dog parks, as it prevents dogs from jumping over it. The entrances to both dog parks consist of an 8 foot by 8-foot fenced area, with a gate leading into both it and into the dog park. This provides a secure area for owners to remove leashes from their dog(s) prior to entering the park, and to put leashes back on their dog(s) before leaving.
