**Vinnie's Lounge Rehabilitation Design Report**

**Submitted To:** City of Clinton Iowa

**By:** Michael Cluchey, Bradley Batterton and Justin Cooks

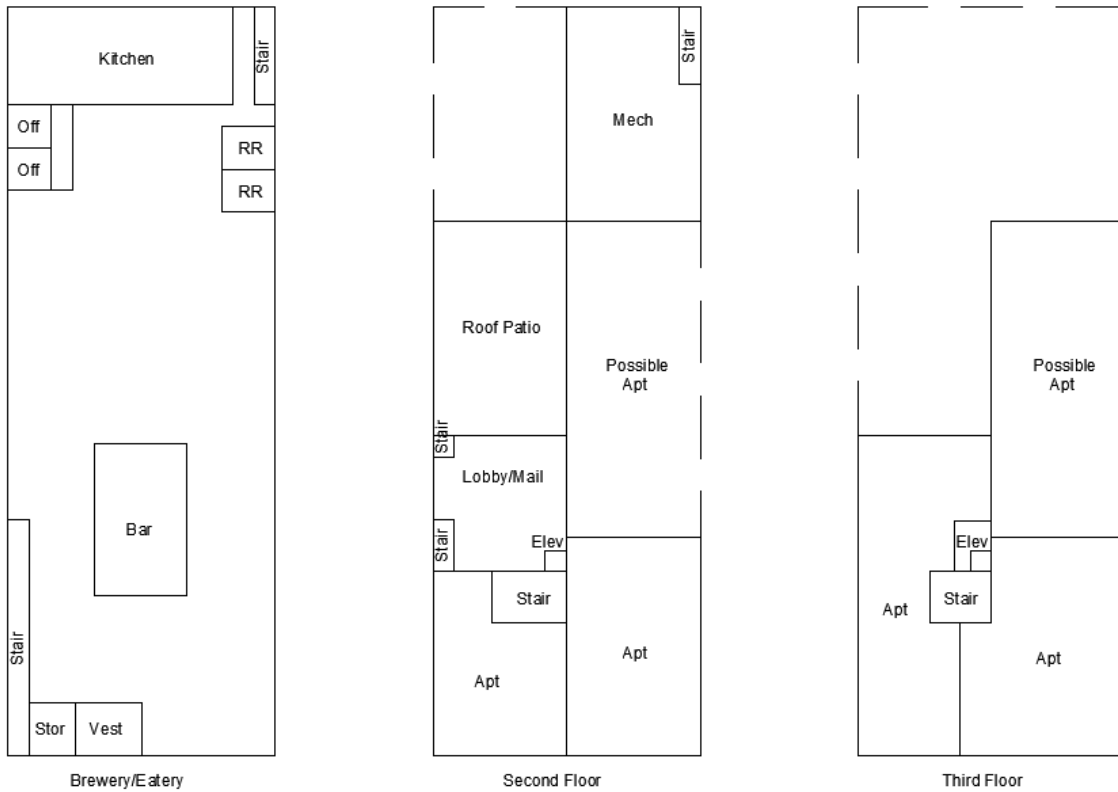
**Figure 7:** Alternative solution for the first floor being a brewery/eatery. The second floor being apartments with a lobby, elevator, roof patio, and mechanical room. And the third floor being apartments with an elevator.

The original design of the project we have worked on is depicted in figure 6. The first design alternative that we considered for the first floor space was a large bar/restaurant. This included designs for dining, bar, kitchen, restrooms, and storage spaces. We provided what this layout would look like in figure 7. Some possible examples of this establishment would include Whiskey Road in downtown Cedar Rapids, or Big Grove Brewery in Iowa City. A picture of these establishments are shown in figure 2 and in figure 3. Another option for the first floor that we had discussed with the client was for it to be used for an entertainment-style business. This involved a design with large open spaces, separate offices for management, restrooms and storage spaces. Indoor virtual golf simulators, and hatchet throwing were two popular options that fell into this category that we decided to include in the possible alternatives. An example of what these layouts would look like are provided in the first two diagrams of figure 8.

We also discussed turning the second and third floors into residential spaces with luxury apartments. An example of what these luxury apartments could look like is given in figure 5. The possible layouts that we discussed for these apartments are given in the last two diagrams of figure 7. We wanted to include three apartments on the second floor, with one of the apartments being built in the right-back open section in between the already existing apartment and the mechanical room. This would allow for more young adults to move into the apartment complex. We also wanted to include a lobby and elevator on this floor. The lobby would allow for residents to have easy access to their apartments, and we would only have to include two entrances from the first floor to enter the lobby instead of making a separate entrance for each apartment. The elevator would be useful because the residents would not have to take the stairs to get to their apartments and make it easier to carry groceries and appliances to their apartments. The third floor would also include three apartments with one of the apartments being above the apartment that we would build in between the back apartment on the second floor and the mechanical room. There would also be an elevator to access these apartments.

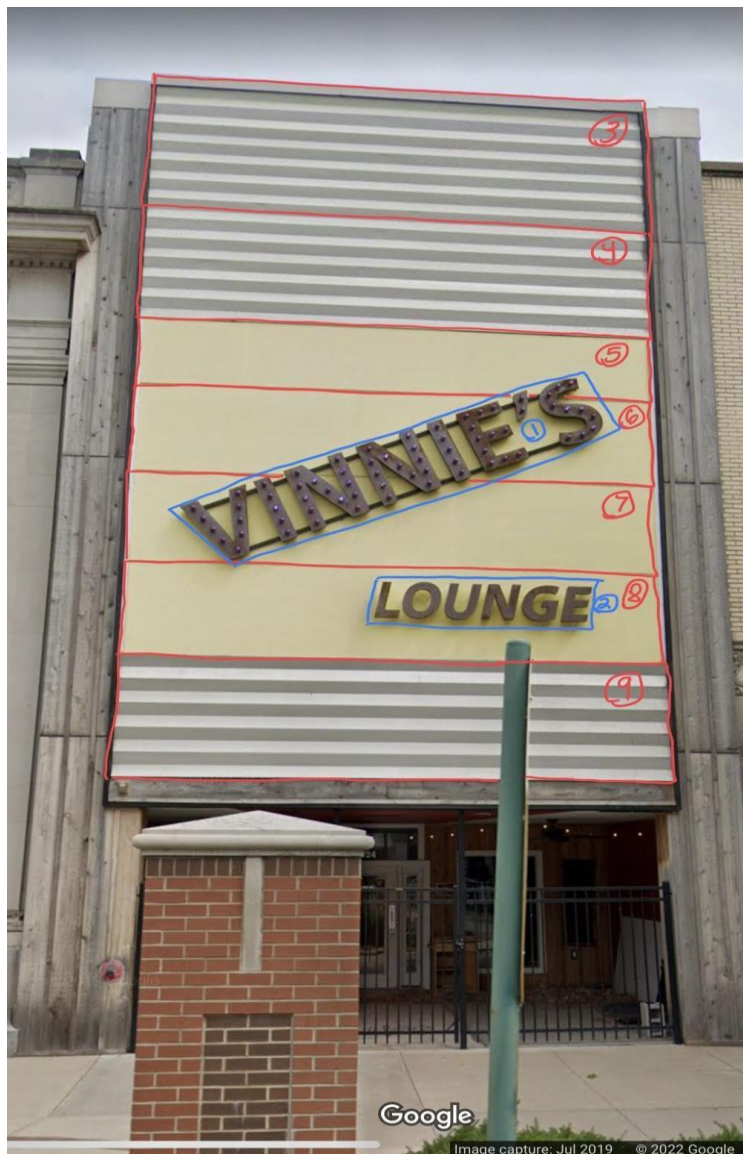
**Figure 10:** Facade removal steps 1-9.

One of the first tasks that we completed for the building design was the removal of the facade. Below in figures 10 through figure 13, we listed the order that we recommend going about removing the facade. We do not recommend taking down more than 25ft x 6ft of the facade at a time due to safety factors. This order does not have to be followed specifically, it is up to the contractor to decide what would be the most efficient and safest way to remove the facade during the process of the demolition. We provided a model of what the front of the building will look like in figure 14, after the facade is removed and the brick exterior of the building is restored for structural integrity and aesthetic purposes.

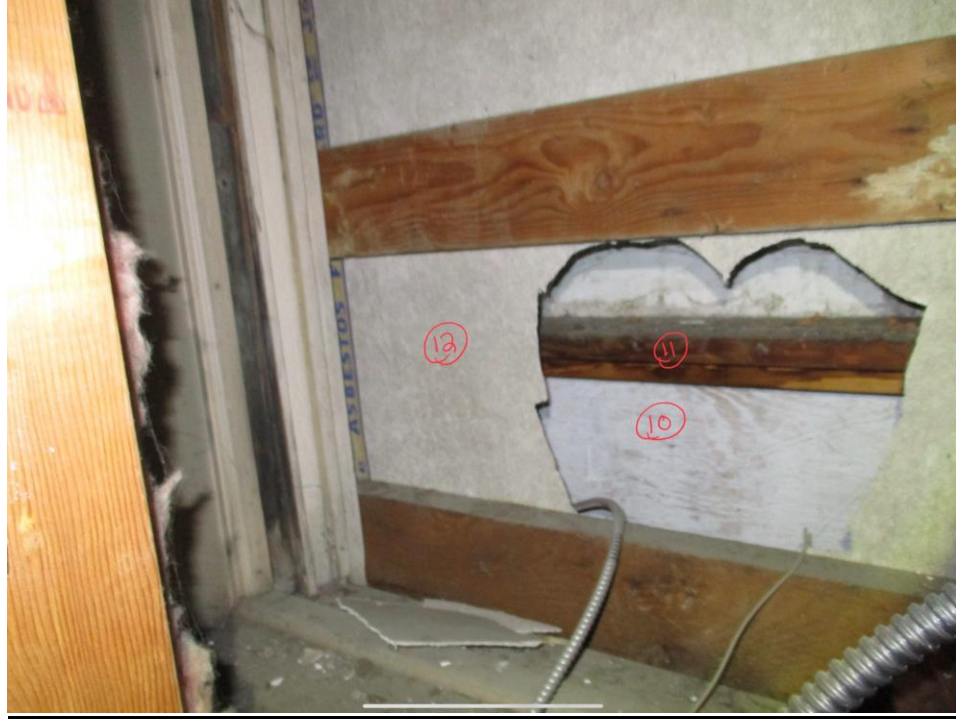
**Figure 11:** Facade removal steps 11-12.

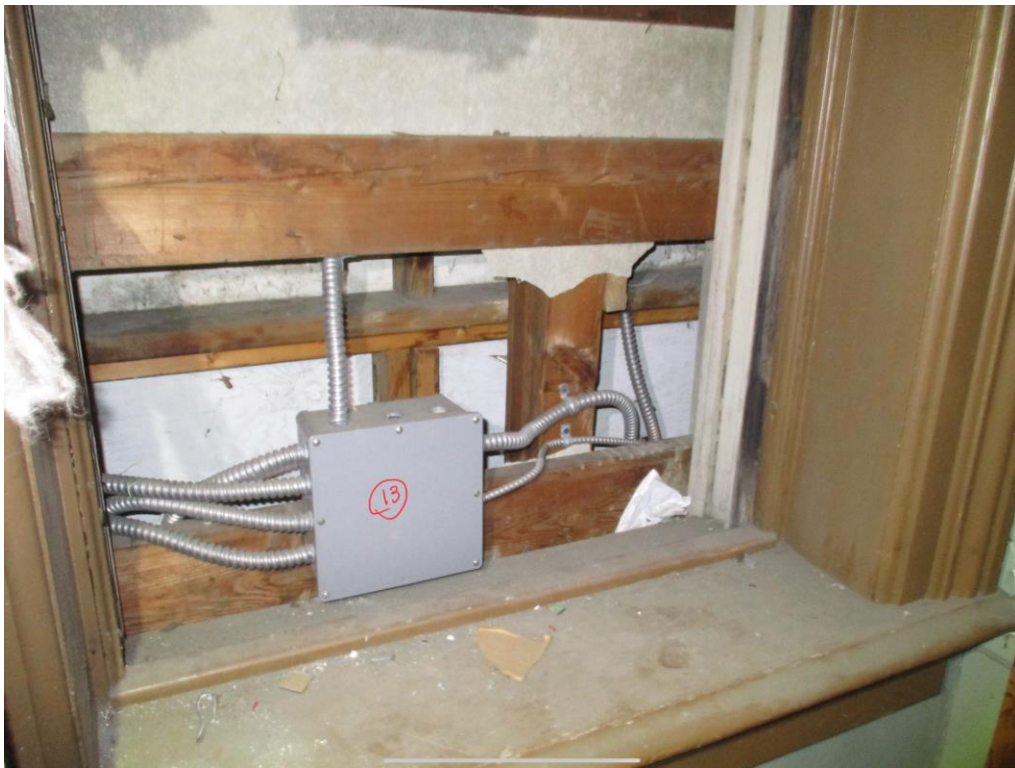
**Figure 12:** Facade removal step 13

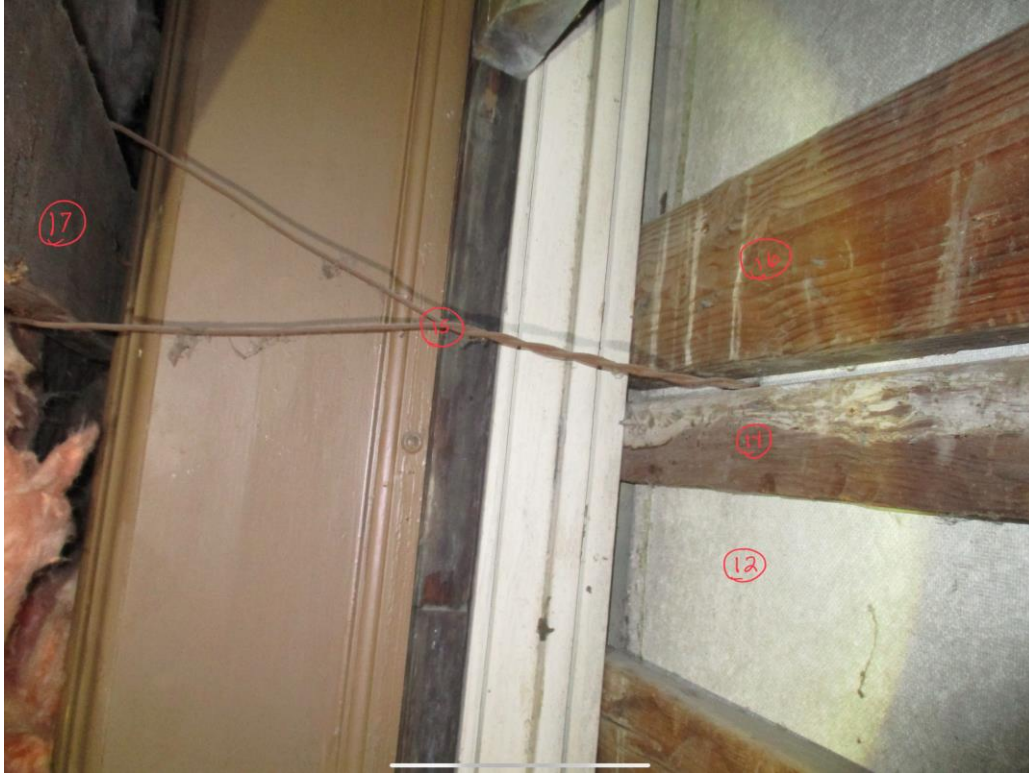
**Figure 13:** Facade removal steps 12, 14-17.

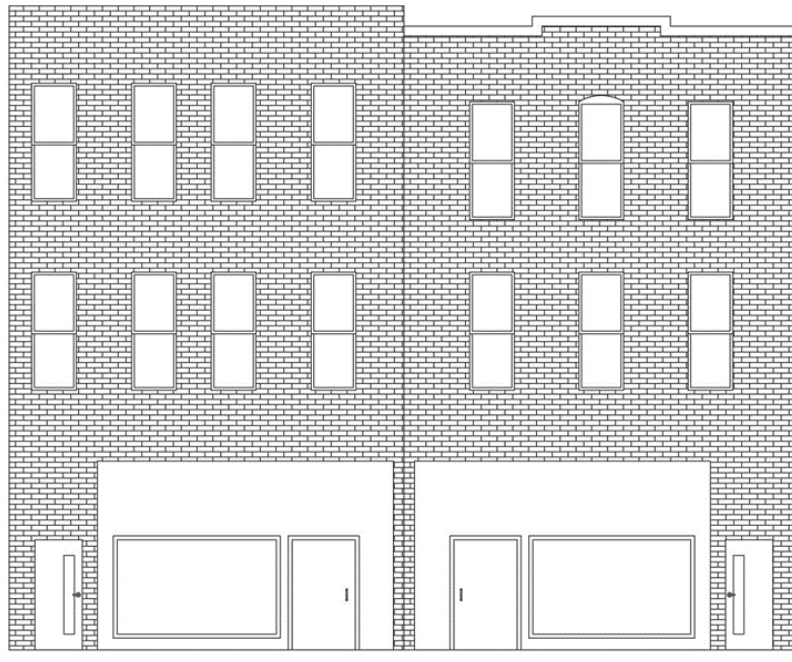
**Figure 14:** The front of the building after the facade is removed and the brick is restored to its original condition.

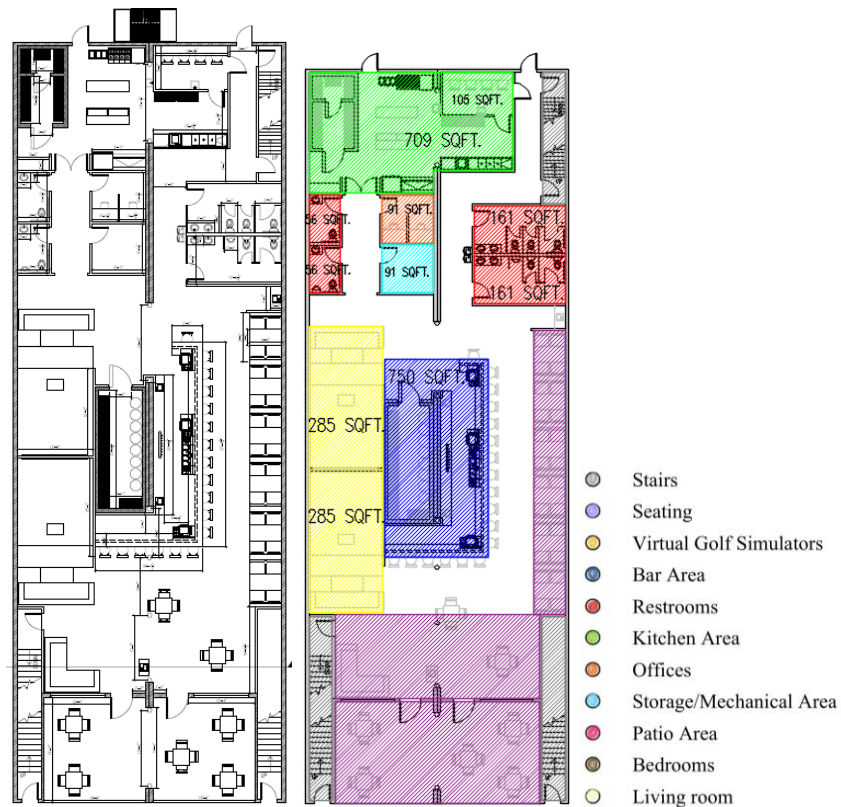
**Figure 15:** Final First Floor Architectural Layout

In order to design the first floor layout of the building, the client's requests were factored into it. This list included two virtual golf simulators, a bar, larger kitchen, seating, restrooms, offices, mechanical room, refrigerator room, and a break room. The seating in the design was based on a 3 foot diameter. The bathroom was made to accommodate the occupancy size of the building and have wheelchair accessible stalls. Per request from the client, the kitchen was expanded to allow more range of motion in the kitchen and ability to put out more food. Employees were made sure to have space of their own, with break rooms, offices and single use bathrooms. To follow ADA standards, all doors and entries 32 inches or larger and all hallways are over 4 feet wide. The golf simulator bay was made to accommodate a group of 4 people at a time and provide the requested atmosphere for the younger crowd. An architectural layout of what the first floor will look like are provided below in figure 15.

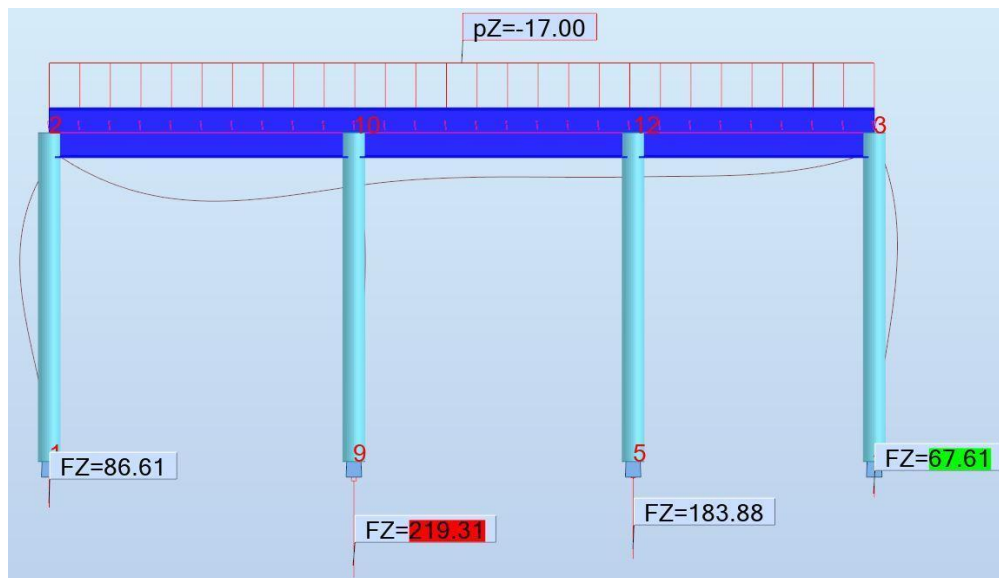
**Figure 23:** Robot Analysis of 32.5 ft of W24x68 Steel Beam with 4 Pipe 10X Columns

To size the support members, we used the LRFD method to find the load that was acting on the wall at its most crucial part. Since the building is located in a downtown area, the building is surrounded by other buildings, so the wind load would not be as much of a factor when calculating the load on the wall. The gravity load in the building was the deciding load for the building. Using dead load and live load values from ASCE 7-22, the load on the wall being taken out came out to be 17 kips per foot (Appendix A). The largest span length of missing brick was 32.5 ft and that is that span we designed for. To support masonry walls the deflection limit has to be under  $L/600$ . Using the robot analysis tool (figure 23), the spanning beam size was determined to be W24X68 A992 Steel Beam. The columns were designed to withstand the axial force of the wall. The size chosen was Pipe 10 XS A992 Steel Columns. The circular shape provided the support with an equally strong x and y axis. The columns were spanned to the foundation wall that will be just below the top of the floor and just above the floor joists.

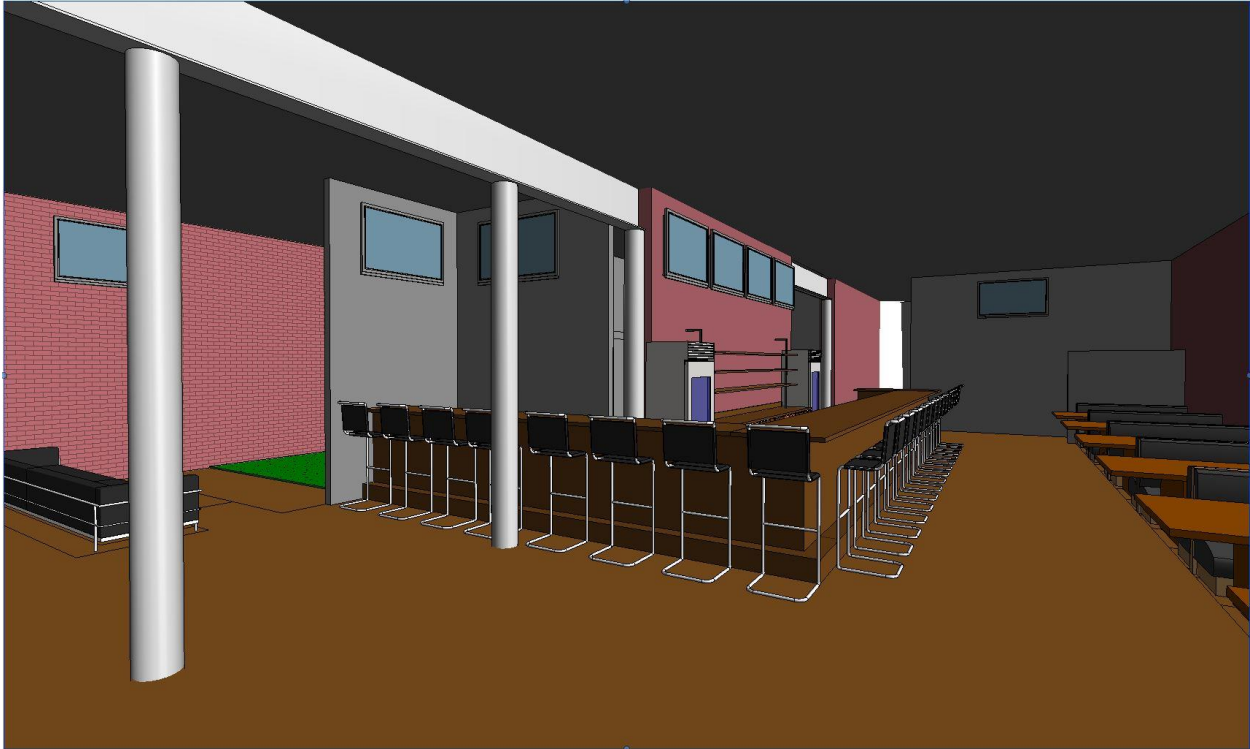
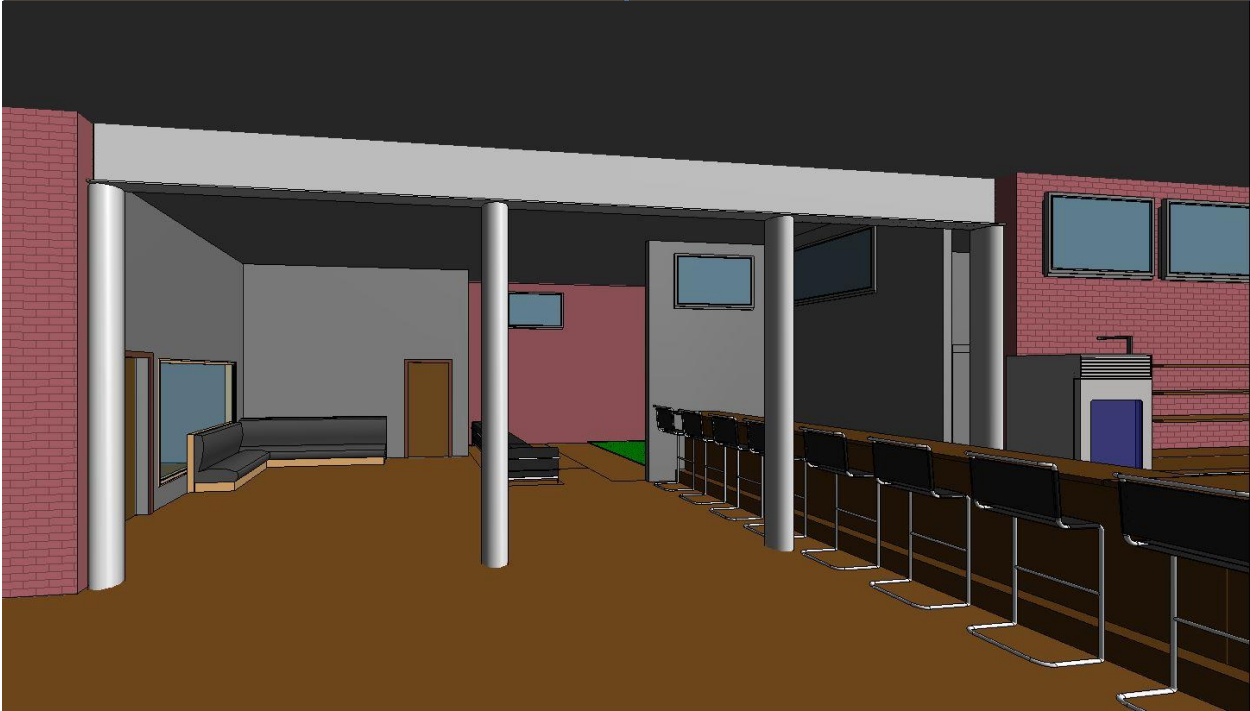
This is a 3D rendering model of what the final design of the first floor bar will look like. The first model is a view of the bar, one of the indoor virtual golf simulators, and seating arrangements from the front west section of the building. The second model is a view from the front east section of the building. The third model is an aerial view and layout of the first floor of the building.

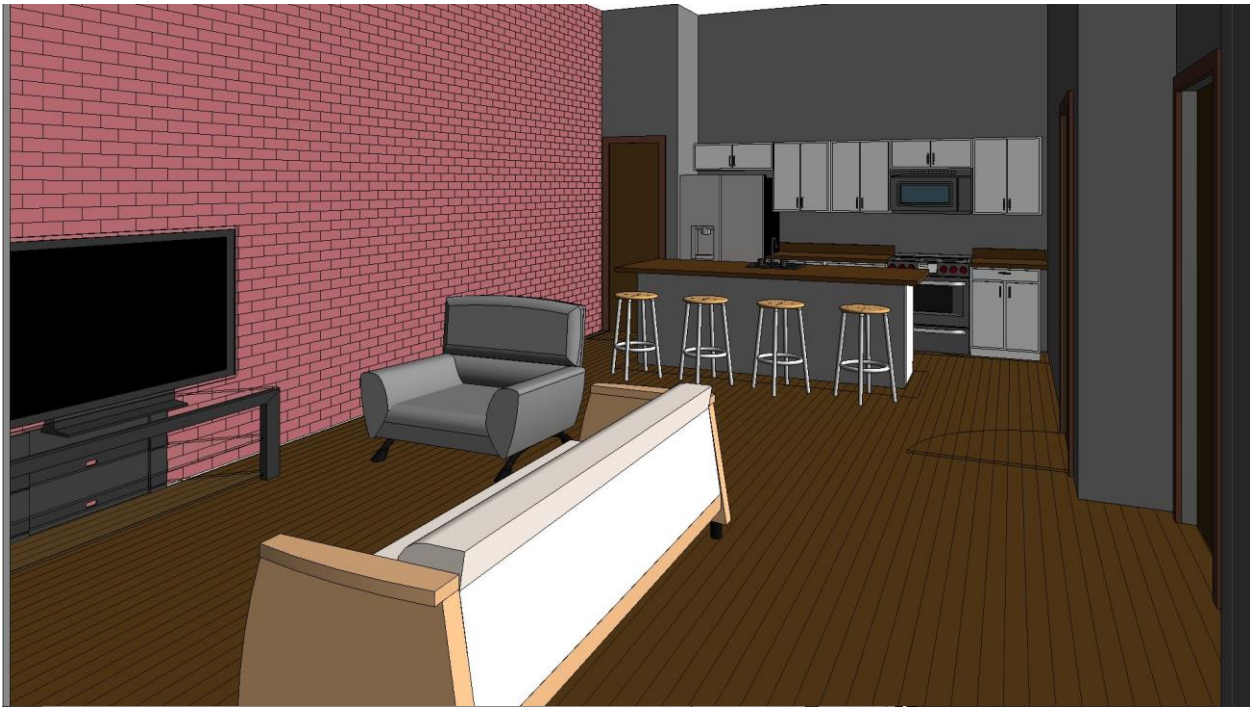
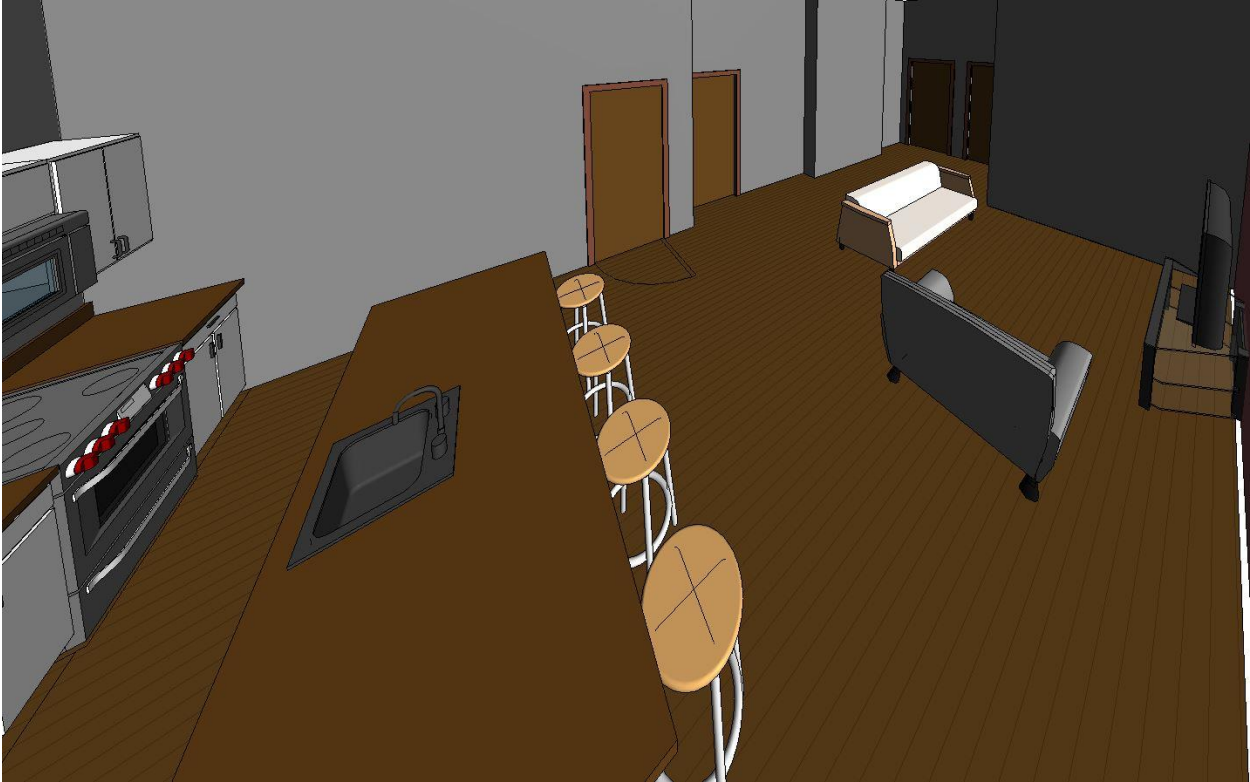
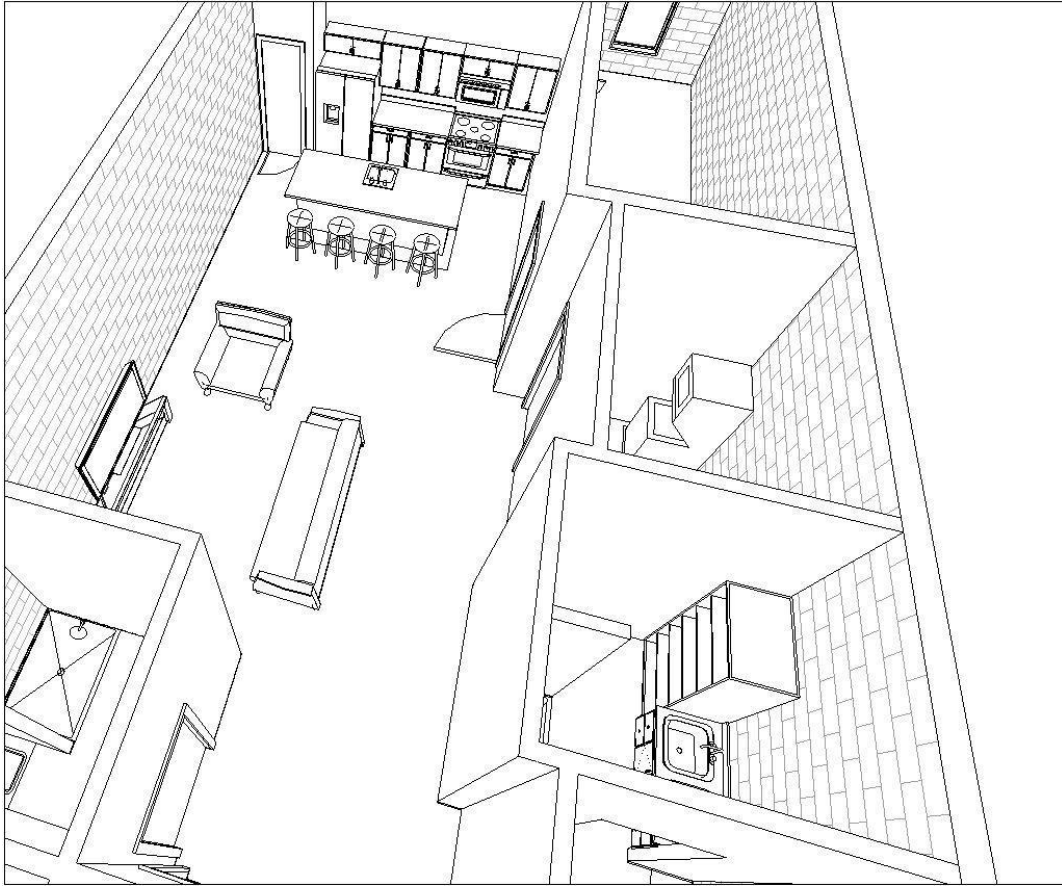
This is a 3D rendering model of the final design of one of the apartments on the third floor. The first model is a view of the apartment from the living room to the kitchen. The second model is a view from the kitchen to the living room. The third view is an aerial view of the apartment and the hallway leading the apartment.
